Garden City Road Safety Audit

Mary Street: Taylor Avenue/U.S. 83B to Kansas Avenue

WILSON
& COMPANY

March 2025

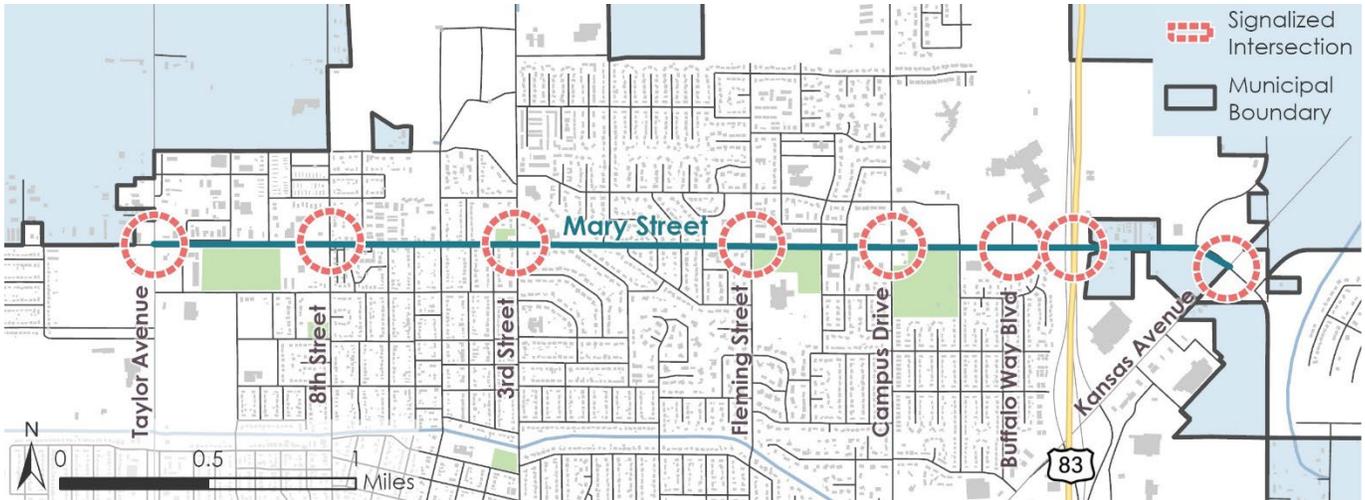
Figure 2 - Project Area

Mary Street, highlighted in Figure 2, runs east-west through the northern half of Garden City, Kansas. Figure 3 shows a typical roadway section of Mary Street in between the intersections. It is a four-lane undivided street with no turn lanes throughout most of the corridor (other than at some of the signalized intersections). There are generally attached sidewalks throughout most of the corridor and no bike lanes.

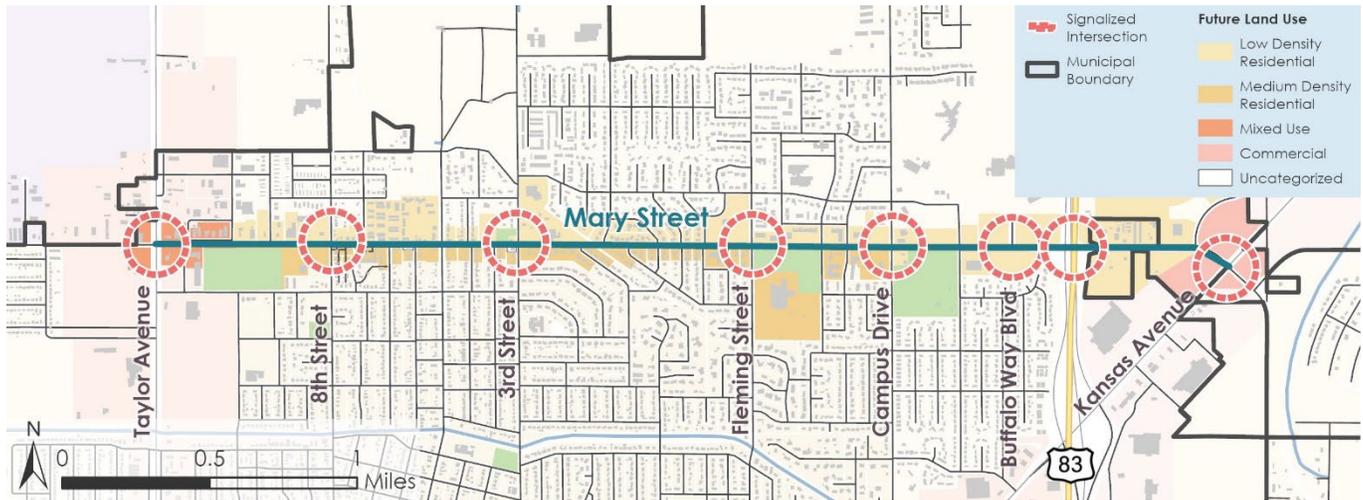
Figure 4 - Future Land Use along Mary Street Corridor. Source: City of Garden City, Kansas

The Garden City Comprehensive Plan outlines the preferred future land uses along the Mary Street corridor, which does not represent a major departure from the current pattern. Two notable changes are the inclusion of a mixed-use district around the Mary Street and W Taylor Avenue intersection and the inclusion of additional medium-density housing in the adjacent southern neighborhoods. The recommended future land use classifications are shown in Figure 4. In addition to land use recommendations, the Comprehensive Plan provides guidance and goals for neighborhood development and community design that would complement the safety improvements recommended for the Mary Street corridor.

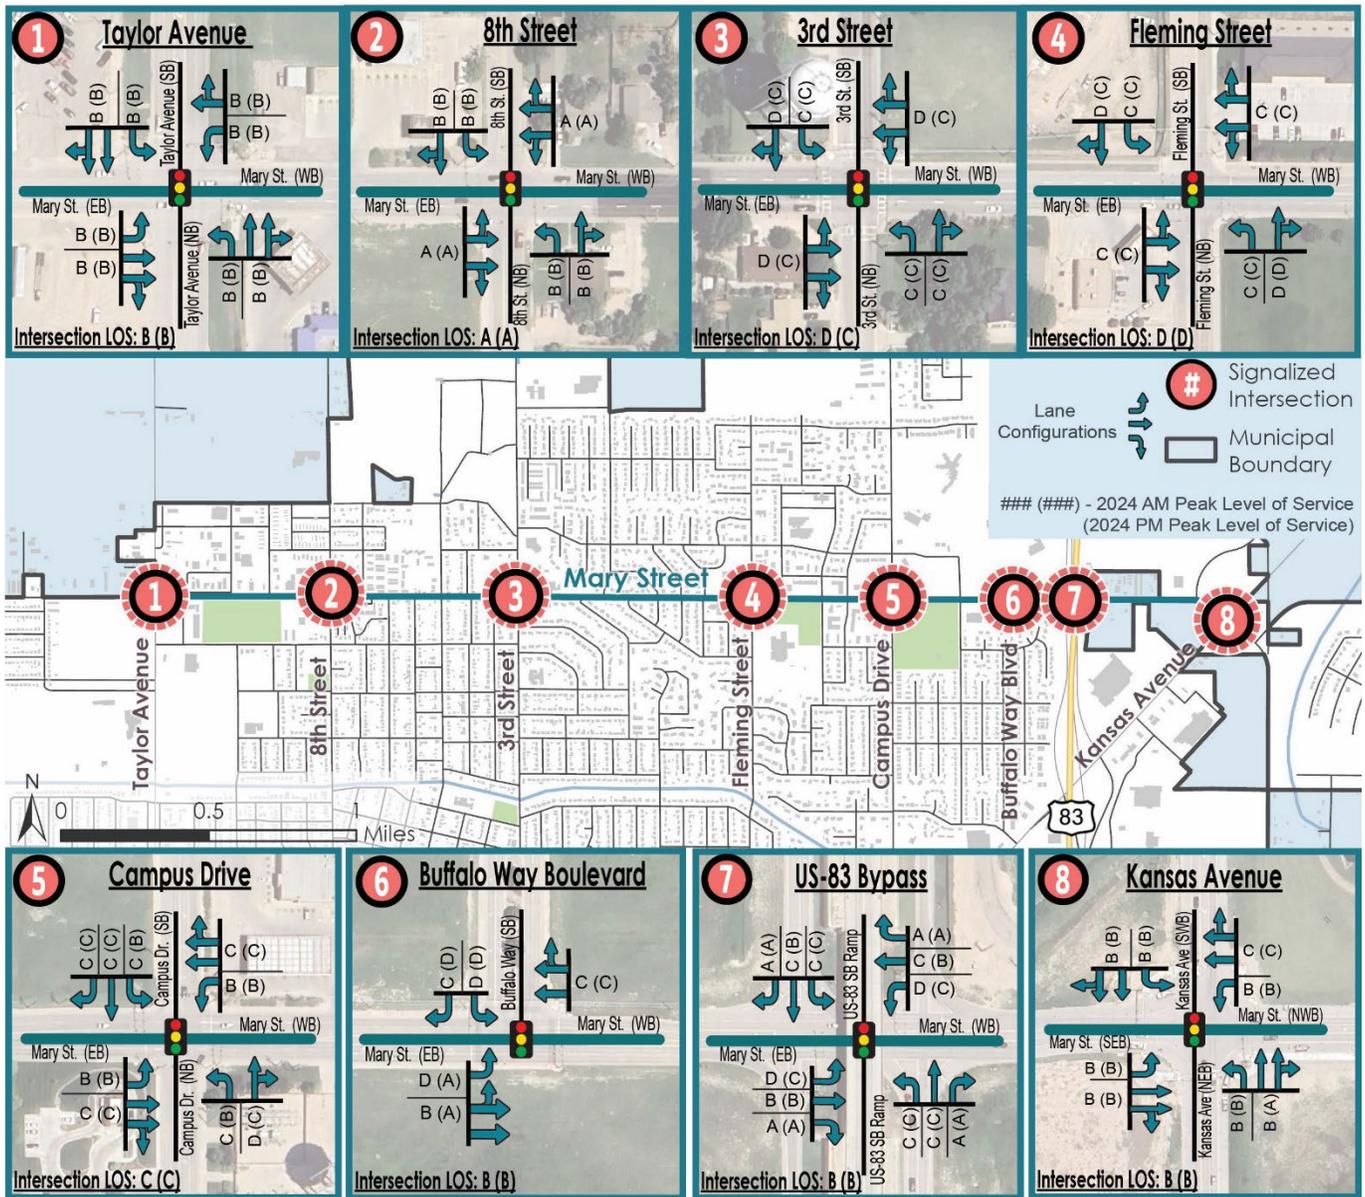
Figure 7 - Existing Peak Hour Traffic Operations on Mary Street

The results of the traffic operations analysis of Mary Street during the AM and PM peak hours are displayed in Figure 7. All of the study intersections are reported to operate at LOS C or better, except for Mary St/Fleming St, which is reported to operate at LOS D during the AM peak hour. Additionally, all of the individual movements at the study intersections are reported to be operating at, or better than, LOS D. The intersections that experience LOS D level delay for individual movements include: 3rd Street, Fleming Street, Campus Drive, Buffalo Way Boulevard, and at the U.S. 83 off-ramps.

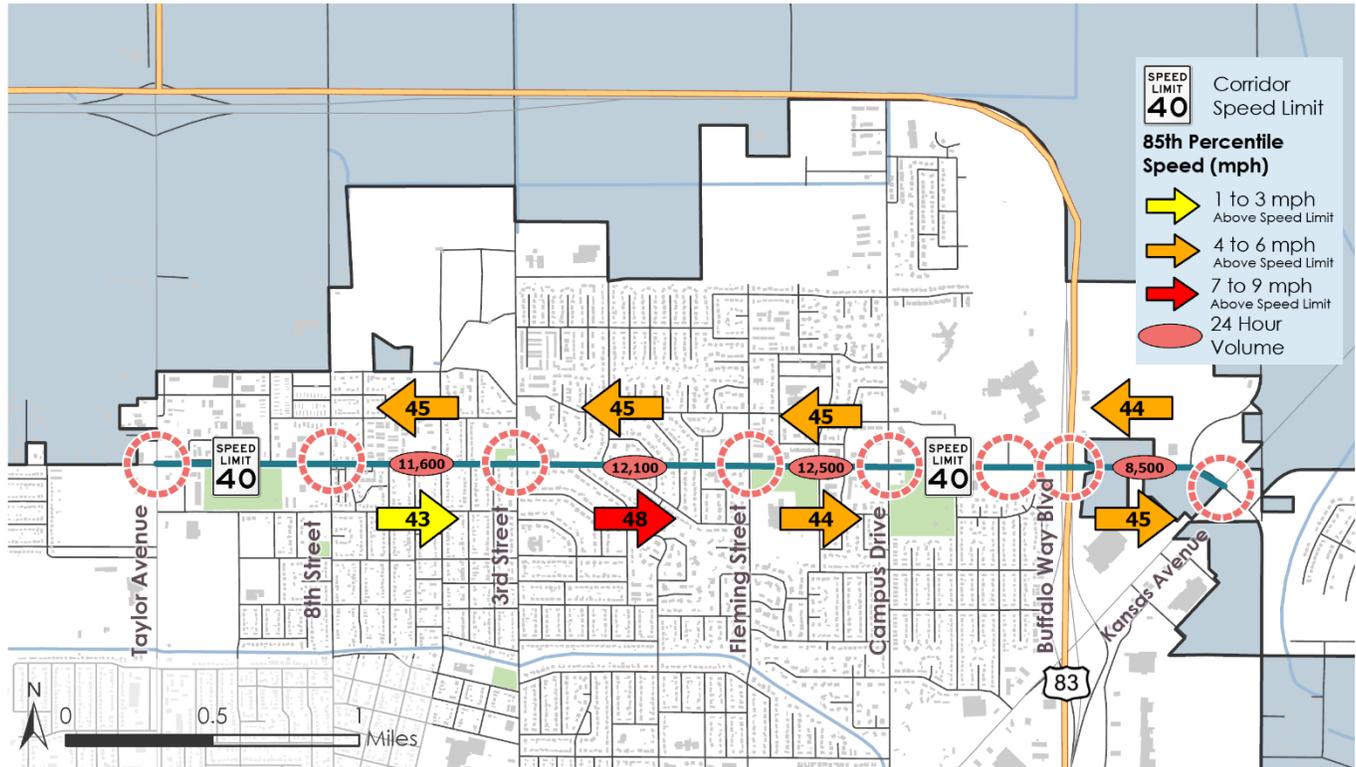
Figure 10 - Mary Street Speed Limits and Vehicle Speeds Summary

The posted speed limit along Mary Street is 40 mph across the study corridor. Vehicle speed data was collected at four locations, summarized in Figure 10 using the 85th percentile speed in both the westbound and eastbound directions on Mary Street. The 85th percentile vehicle speeds generally don't exceed 5 mph over the posted 40 mph except heading eastbound on Mary Street in between 3rd and Fleming Streets. The average 85th percentile speed across the corridor is about 44.9 mph.

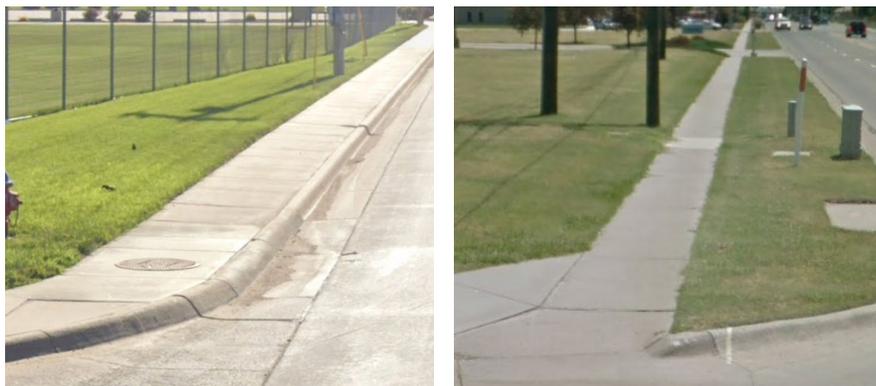
Existing sidewalks are mostly attached to the roadway curb (with some sections detached from the roadway), vary from about 3 to 5 feet in width and look generally like Figure 12. There are no sidewalks on Mary Street from Buffalo Way Boulevard east to Kansas Avenue. The Taylor and U.S. 83 intersections also lack marked crosswalks. The crosswalks that are marked include: standard, continental, and brick markings. There is one recently installed marked crosswalk with Rectangular Rapid Flashing Beacon (RRFB) pedestrian warning signage at the B Street intersection near 8th Street.

Figure 12 - Photos showing examples of attached (left) and detached (right) sidewalks along Mary Street

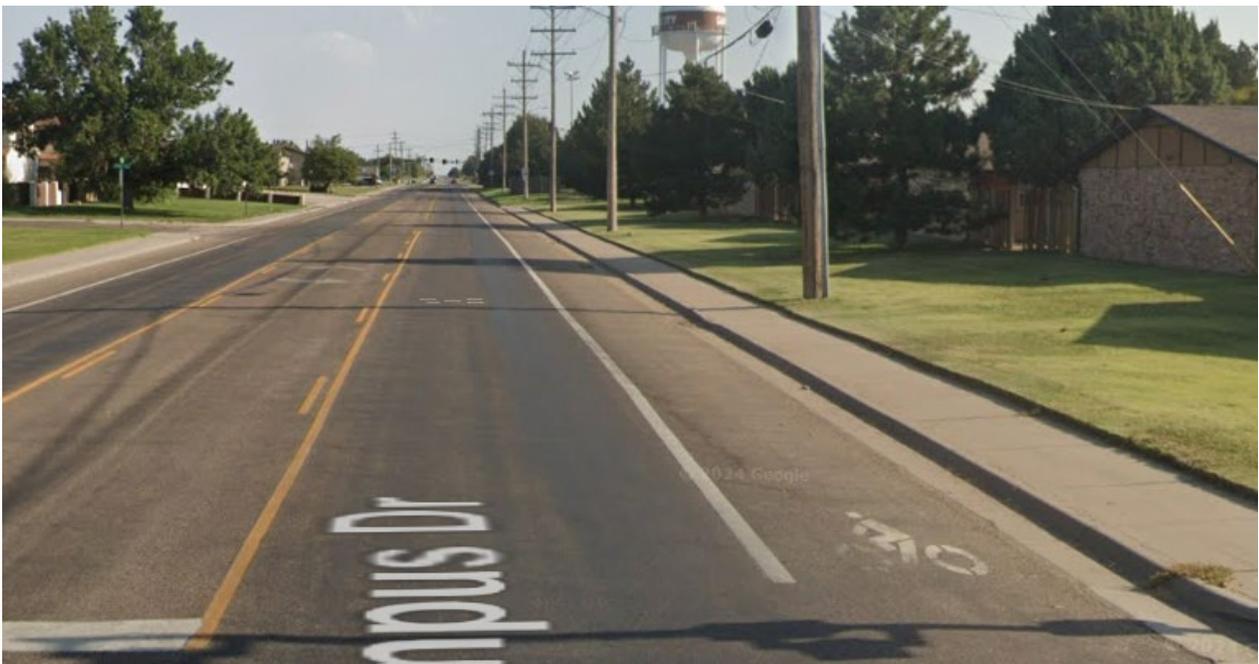
Figure 13 shows trail and bicycle infrastructure that was sourced from the Garden City Comprehensive Plan (2021). Currently, there is one marked bike lane touching Mary Street – on Campus Drive south of Mary Street, shown in Figure 14. The comprehensive plan called for the installation of a similar bike lane on Main Street heading both north and south of Mary Street.

Figure 14 - Photo of bike lane on Campus Drive

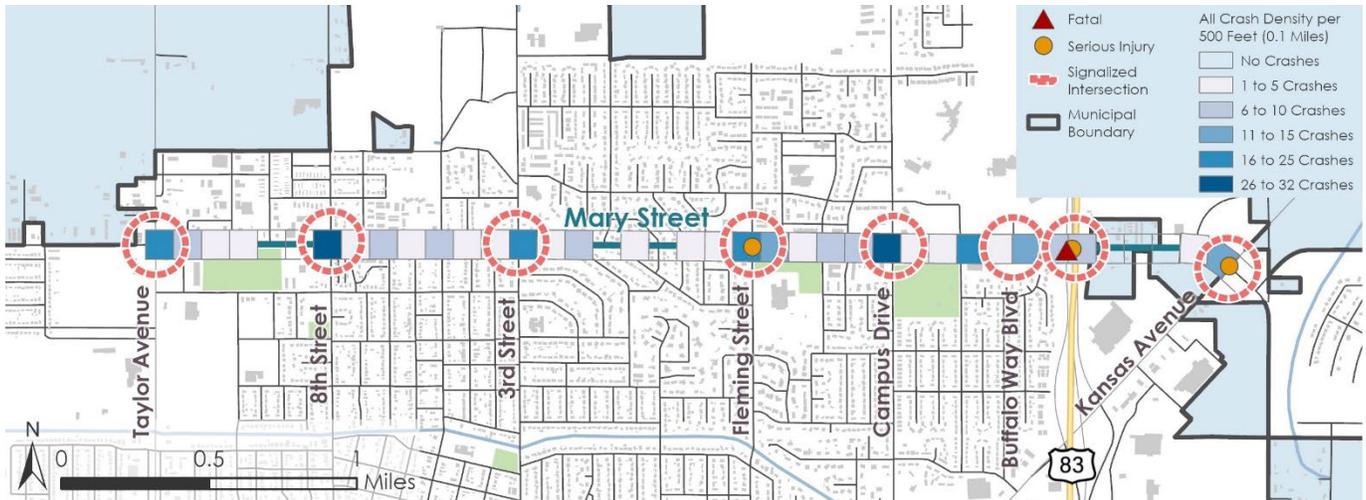
Between 2018 and 2022, 283 crashes occurred along Mary Street within the RSA project limits. There was 1 Fatality, 3 Suspected Serious Injuries (SSI), 57 Injuries, and 222 Property Damage Only (PDO) crashes. Figure 18 summarizes the crash density on the corridor by 500-foot segments and show that most of the crashes are clustering at signalized and unsignalized intersections.

Figure 18 - Corridor crash map overview

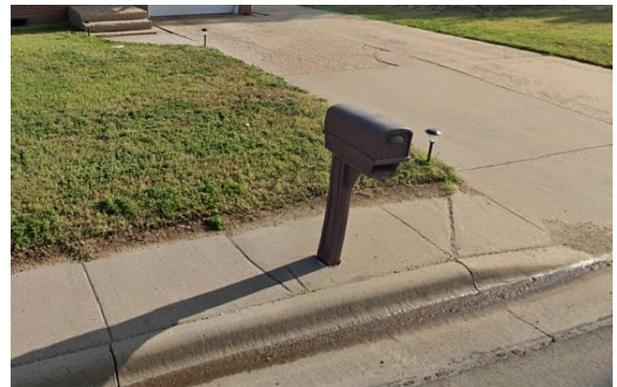
- Most curb ramps lacked truncated domes.
- Several locations had non- ADA-compliant curb ramps
- The use of pedestrian countdown signals was inconsistent at intersections along the corridor.
- The sidewalks west of E Lamplighter Lane were narrow (approximately three feet) and blocked by objects such as mailboxes and power poles (Figure 26 and Figure 27).
- There were no sidewalks east of Buffalo Way Boulevard and most sidewalks were abutting curb.

Figure 27 - Narrow sidewalk with obstruction

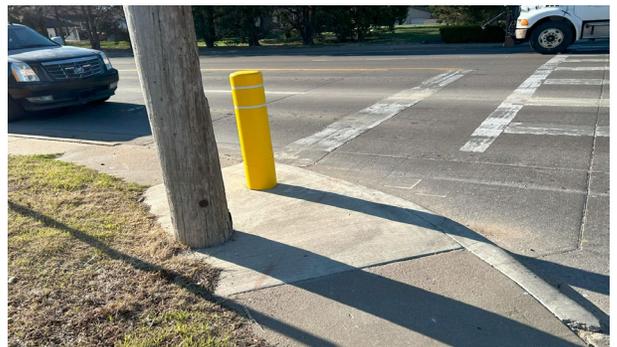
Figure 26 - Non-ADA compliant pedestrian curb with pole obstruction

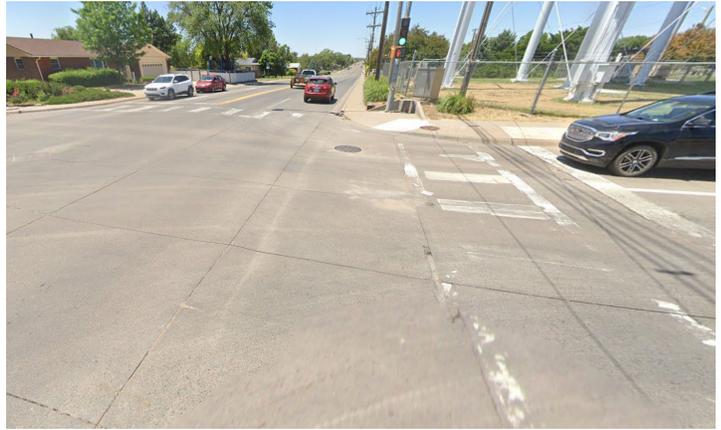
Figure 28 - Faded crosswalk that needs to be repainted

- There were several locations at signalized intersections where crosswalk striping was not found or was faded at the time of the field visits (Figure 28).
- Most unsignalized intersections do not have stop lines at Mary Street.

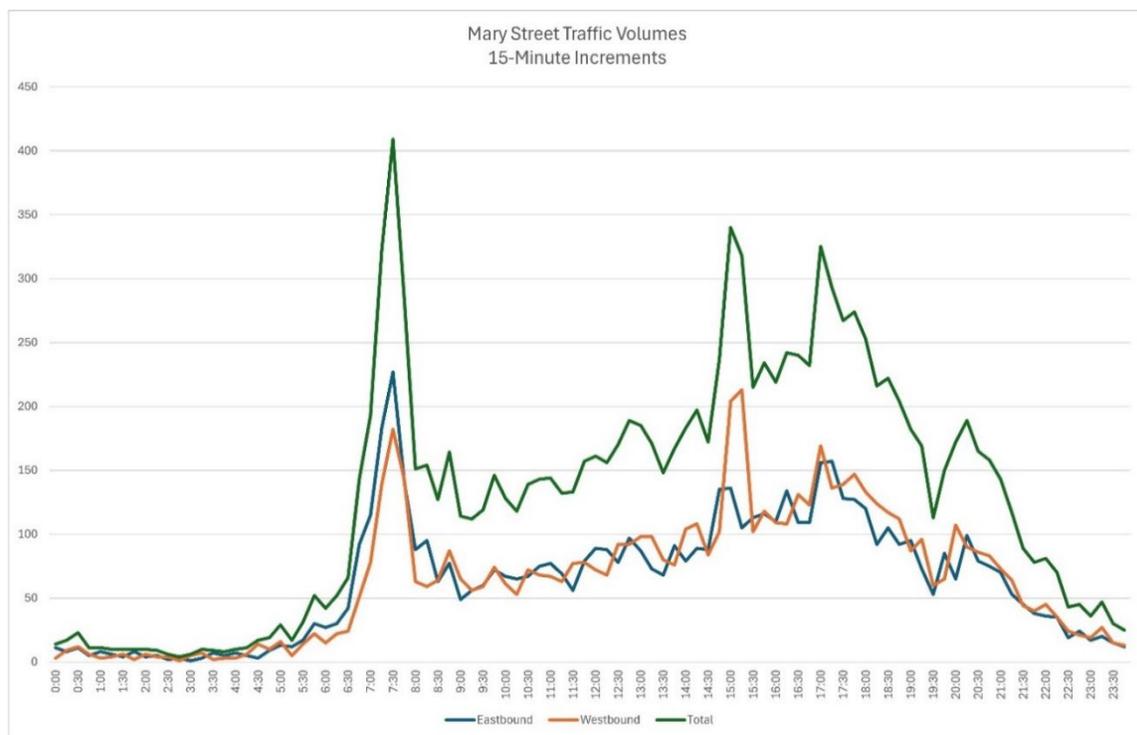
Figure 30 - Mary Street Traffic in 15-Minute Increments

Although the analysis of the Mary Street/Campus Drive intersection indicates that it may operate close to its capacity with a road diet during peak periods (volume-to-capacity ratio = 0.91), any congestion that occurs may be short lived. The daily traffic count collected on Mary Street just west of Campus Drive was plotted in 15-minute increments, as shown in Figure 30. The data indicates that the peak periods of traffic in the vicinity of the Mary Street/Campus Drive intersection are brief, with one 15-minute period in the morning (EB, 7:30-7:45) and two 15-minute periods in the afternoon (WB, 3:00-3:30) having a directional volume greater than 200 vehicles, which is likely due to the proximity of the high school. The traffic analysis conducted for this RSA is based on the heaviest 15-minute period in the AM and PM peak hours, by use of the peak-hour factors (PHF) as determined from the intersection counts (PHF = 0.70 in the AM, PHF = 0.78 in the PM). Thus, it is expected that there would be limited, if any, congestion at the intersection outside of these brief periods. Furthermore, any congestion that may occur during these brief periods would likely only develop on days during which school is in session, since the traffic generated by the high school is likely the cause of the spikes in traffic volumes.

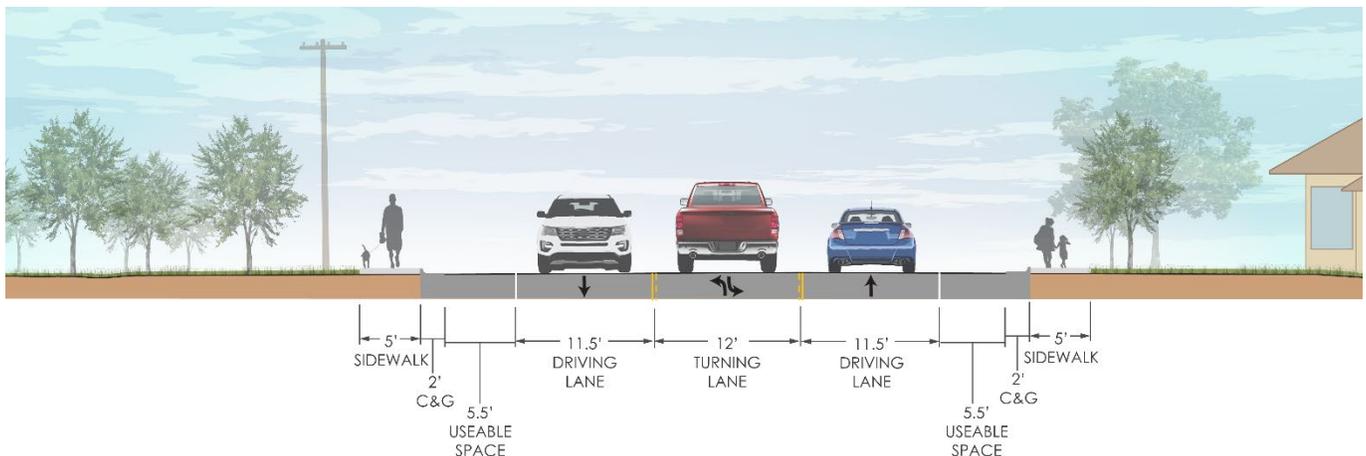
Figure 31 – Mary Street Alternative Roadway Typical Section for Road Diet

Convert the existing four-lane undivided roadway to a three-lane roadway consisting of two through lanes and a center two-way left-turn lane (TWLTL) – see Section: *Road Diet Analysis* for further discussion and analysis of the potential benefits of a road diet conversion of Mary Street. A Road Diet can be a low-cost safety solution when planned in conjunction with a simple pavement overlay, and the reconfiguration can be accomplished at no additional cost. However, the need for traffic signal modifications or reconstruction to accommodate a Road Diet on Mary Street would need to be evaluated. If required, traffic signal modifications or reconstruction, including flashing yellow arrows (FYA) on signal heads, could add significant cost to a Road Diet conversion of Mary Street. An example cross section of the roadway with a road diet implemented is shown in Figure 31, although the specific lane widths would be determined later.

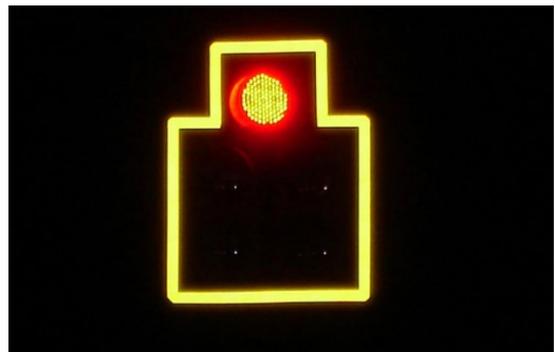
Figure 34 - Retroreflective borders on signal head backplates. (Source: South Carolina DOT)

Backplates added to a traffic signal head improve the visibility of the illuminated face of the signal by introducing a controlled-contrast background. The improved visibility of a signal head with a backplate is made even more conspicuous by framing it with a 1- to 3-inch yellow retroreflective border. Signal heads that have backplates equipped with retroreflective borders are more visible and conspicuous in both daytime and nighttime conditions. A reduction in total crashes of 15% can be expected at intersections where backplates with retroreflective borders are implemented.

Recommendation: Consideration should be given to replacing the signal head backplates with retro-reflective backplates (such as what already exists at the Mary Street/Kansas Avenue intersection).

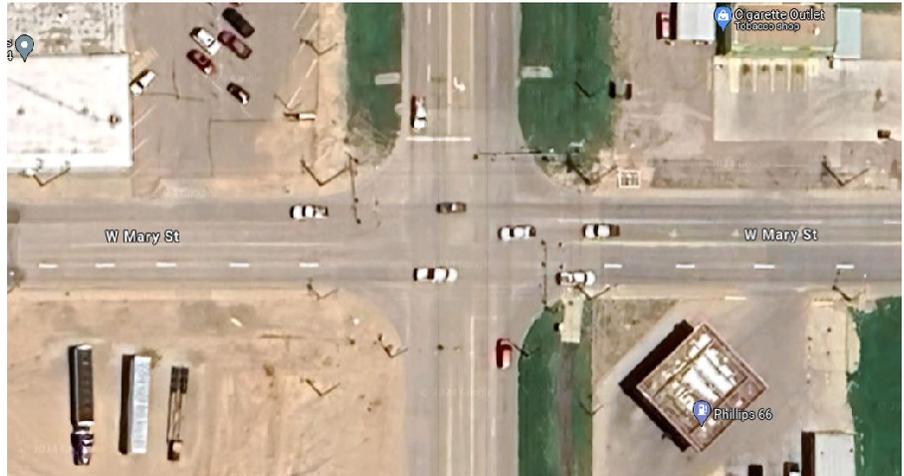
The Mary Street & Taylor Avenue/U.S. 83B intersection is signalized and represents the western boundary of the project study area, shown in Figure 35. The east leg of Mary Street consists of one westbound through lane, a dedicated left-turn lane, and two eastbound receiving lanes. The west leg of Mary Street includes a dedicated eastbound left-turn lane and two through lanes. The north and south legs of Taylor Avenue include a dedicated left-turn lane and two through lanes. Right-turns must be made from the shared through lane in all directions. There is protected/permissive left-turn phasing for every approach.

Figure 35 - Aerial Image of Taylor Avenue/U.S. 83B Intersection

Attached sidewalks are present on the east and west legs of Mary Street. There are no sidewalks along Taylor Avenue; however, the north leg of the Talley Trail begins on the east side of the intersection running south. The recent Garden City Comprehensive Plan proposed to extend the Talley Trail north of this intersection, indicating that pedestrian signals will be warranted at this intersection in the future (Refer to the Talley Trail RSA for further recommendations related to this development). There is also no pedestrian signal heads at this intersection.

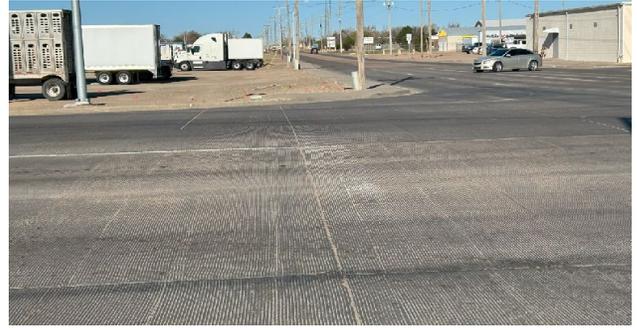
Figure 37 - Photo at Mary St. & Taylor Ave. intersection showing poor striping conditions

- No curb ramp is provided on the northeast corner to connect the sidewalk on the northeast side of the intersection to the trail system on the southeast side.
- There are no painted crosswalks or pedestrian signals at this intersection.
- The curb ramp on the southwest corner of the intersection is missing truncated domes.
- Except for the north leg, stop lines were missing or faded (Figure 37).

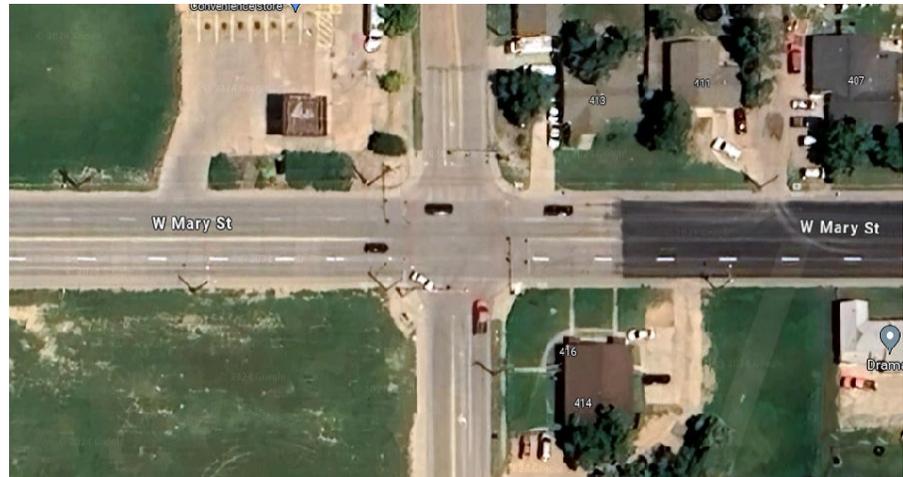
Mary Street and 8th Street is a signalized intersection (Figure 38). The east and west legs of Mary Street consist of two through lanes, from which right and left turns are made. The north and south legs of 8th Street include a dedicated left-turn lane and a single through lane in each direction. Right-turns must be made from the shared through lane in all directions. There is protected/permissive left-turn phasing for the westbound, northbound, and southbound approaches. There is a dollar general to the southwest of the intersection that generates a lot of vehicle and pedestrian trips. A dirt path from 8th street to the dollar general is visible through the empty lot.

Figure 38 - Aerial Image of 8th Street Intersection

Attached sidewalks are present on the east and west legs of Mary Street. There are no sidewalks along north of the intersection. Brick crosswalks and pedestrian phasing are present. The 8th Street intersection saw some of the most pedestrian activity with 26 pedestrians crossing the intersection over a 13-hour period.

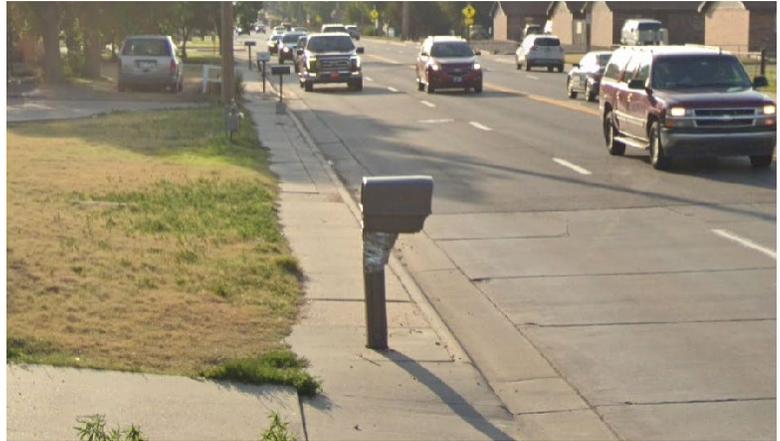
Figure 40 - Photo of a sidewalk on Mary Street obstructed by mailboxes

- The stop lines for all four legs were missing or faded.
- North of Mary Street, no sidewalk exists along the east side of 8th Street.
- The sidewalk on the north side of Mary Street and east of the intersection has a mailbox obstructing the path (Figure 40).

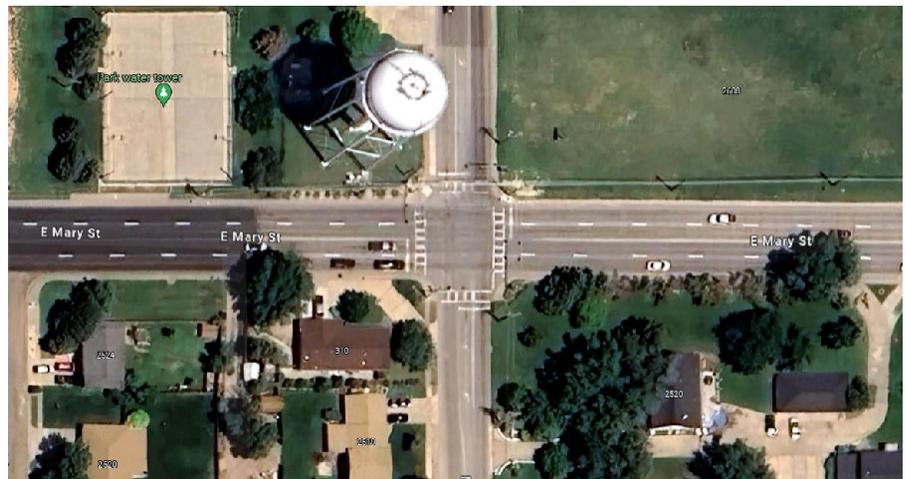
Mary Street & 3rd Street is a signalized intersection (Figure 41). The east and west legs of Mary Street consist of two through lanes, from which right and left turns are made. The north and south legs of 3rd Street include a dedicated left-turn lane and a single through lane in each direction. Right-turns must be made from the shared through lane in all directions. There is protected/permissive left-turn phasing for the northbound and southbound approaches.

Figure 41 - Mary Street & 3rd Street Aerial Map

Attached sidewalks are present on the east and west legs of Mary Street. There are no sidewalks along the east side of the south leg of 3rd Street. There are no bike lanes on Mary Street or 3rd Street. Daily traffic at the intersection is approximately 11,600 VPD on the west and east legs, and 4,700 VPD on the north and south legs. The 3rd Street intersection saw about 14 pedestrians crossing the intersection over a 13-hour period.

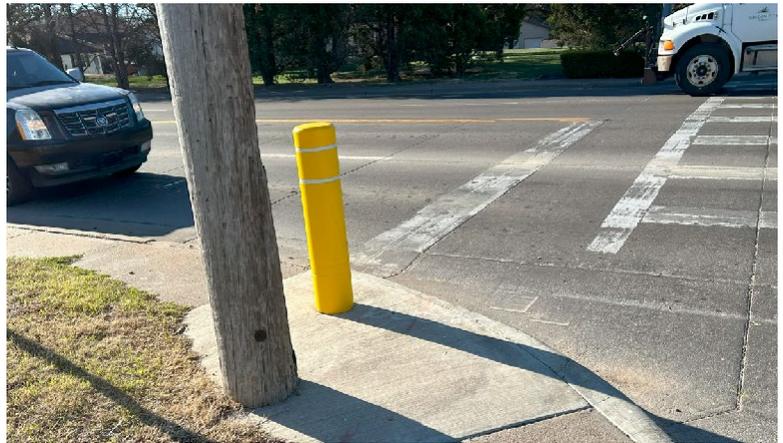
Figure 43 -- Sidewalk Obstructed by Pole and Post

- The painted crosswalks and stop lines were faded on all four legs of the intersection.
- The curb on the NW corner of the intersection is damaged with missing portions.
- All four curb ramps are missing truncated domes.
- South of Mary Street, no sidewalk is on the east side of 3rd Street.
- The sidewalk on the NE corner of the intersection does not meet ADA requirements due to a power pole and a post obstructing the path (Figure 43).

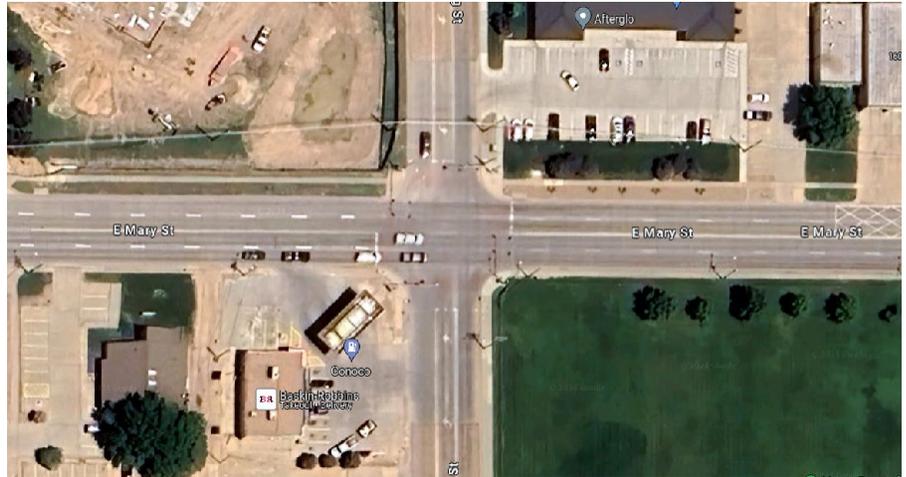
Mary Street and Fleming Street is a signalized intersection (Figure 44). The east and west legs of Mary Street consist of two through lanes, from which right and left turns are made. The north and south legs of Fleming Street include a dedicated left-turn lane and a single through lane in each direction. Right-turns must be made from the shared through lane in all directions. There is protected/permissive left-turn phasing for the northbound and southbound approaches.

Figure 44 - Aerial Image of Fleming Street Intersection

A mix of attached and detached sidewalks are present at this intersection. Daily traffic at the intersection is approximately 12,200 VPD on the west leg, 13,100 VPD on the east leg, 3,100 VPD on the north leg, and 5,700 VPD on the south leg. There were 27 pedestrian crossings observed over a 13-hour period at this intersection.

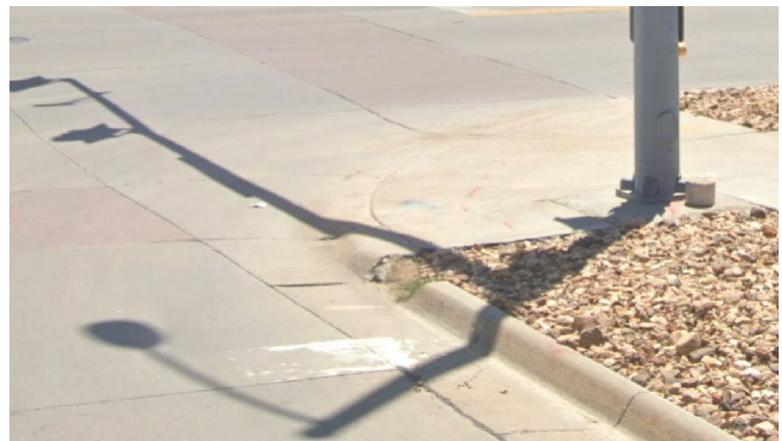
Figure 46 - Missing Truncated Domes

- The painted stop lines were faded on all four legs of the intersection.
- All four curb ramps are missing truncated domes (Figure 46).

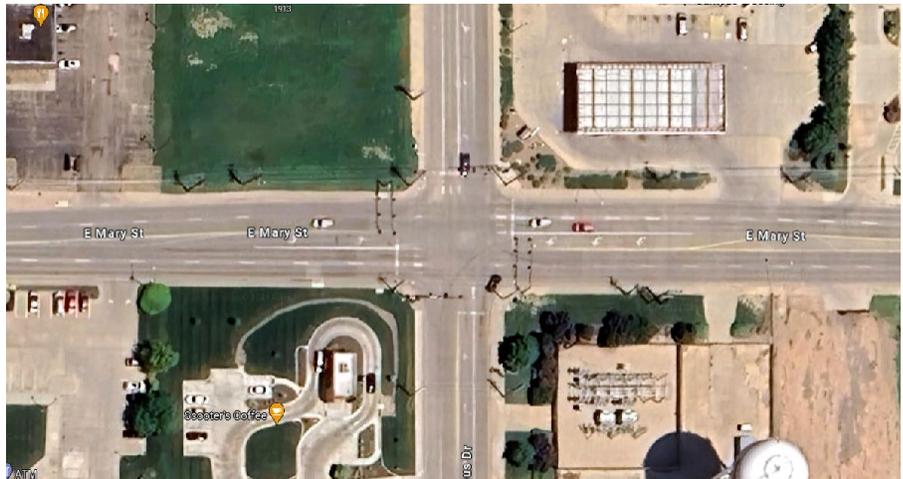
Mary Street and Campus Drive is a signalized intersection (Figure 47). The east and west legs of Mary Street consist of two through lanes and a dedicated left-turn lane. The north and south legs of Campus Drive include dedicated left-turn lanes and a single through lane in each direction. Right-turns must be made from the shared through lane in all directions except for the southbound approach, which has a dedicated right-turn lane. There is protected/permissive left-turn phasing for every approach.

Figure 47 - Aerial Image of Campus Drive Intersection

Attached sidewalks are present and there are bike lanes on Campus Drive south of the intersection. Daily traffic at the intersection is approximately 12,500 VPD on the west leg, 11,500 VPD on the east leg, 6,600 VPD on the north leg, and 7,600 VPD on the south leg. There were 12 pedestrian crossings observed over a 13-hour period at this intersection.

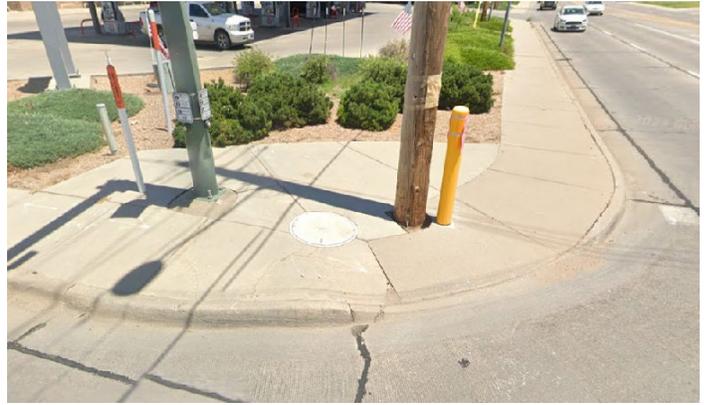
Figure 49 - Power Pole and Post in the Curb Ramp

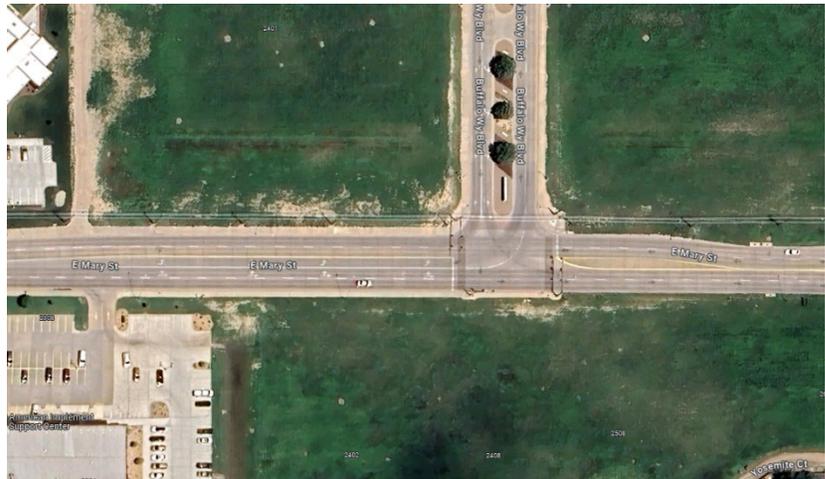
Mary Street and Buffalo Way Boulevard is a signalized T-intersection (Figure 50) with the north leg serving as the access for Garden City High School. The eastbound approach has a dedicated left-turn lane, a shared left-turn/through lane, and a dedicated through lane. The westbound approach has two lanes, with right turns being made from the outside through lane. The southbound approach has a left-turn lane and a right-turn lane. The eastbound approach has protected/permissive left-turn phasing.

Figure 50 - Aerial Image of Mary Street & Buffalo Way Boulevard

Attached sidewalks are present along Buffalo Way Boulevard and Mary Street west of Buffalo Way Boulevard, but there are no sidewalks to the east. Daily traffic at the intersection is approximately 11,200 VPD on the west leg, 8,900 VPD on the east leg, and 5,300 VPD on the north leg. There were 12 pedestrian crossings observed over a 13-hour period at this intersection.

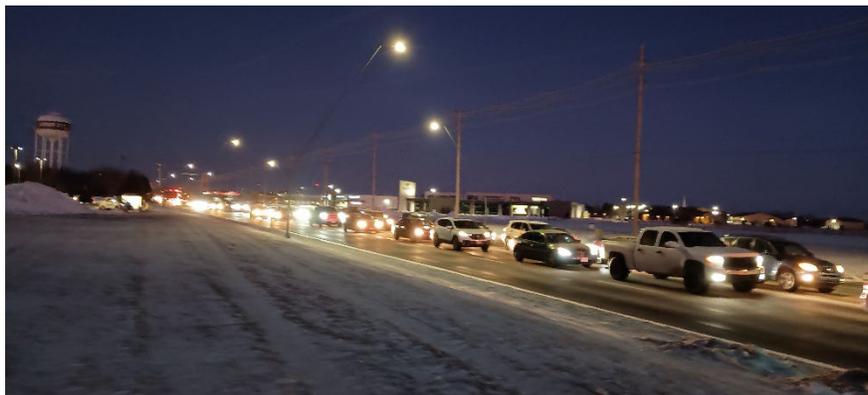
Figure 52 - Image capturing the vehicle queueing along Mary Street near the Buffalo Way Boulevard in the AM peak

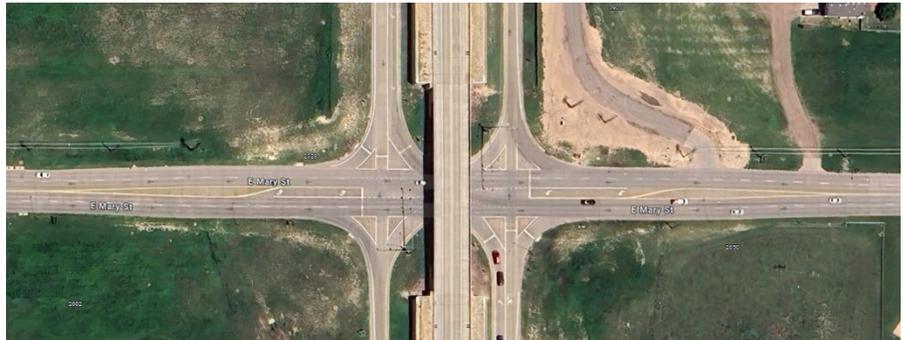
Figure 53 - Aerial Image of U.S. 83 Bypass and Mary Street Intersection

Mary Street is grade-separated with U.S. 83, passing underneath the mainline and with a single-point signalized intersection with its on-/off-ramps (Figure 53). Every approach has a dedicated left-turn lane with protected-only signal phasing and a channelized right-turn. The eastbound/westbound approaches have two through lanes and the northbound/southbound approaches have a single through lane.

There are no pedestrian or bicycle accommodations at this intersection. Daily traffic at the intersection is approximately 8,900 VPD on the west leg, 8,200 VPD on the east leg, and 1,600 VPD on each of the on-/off-ramps to/from U.S. 83.

- Add/repair sidewalks as the area develops.
- Replace circular red signal indications in the left turn signal heads with red arrows

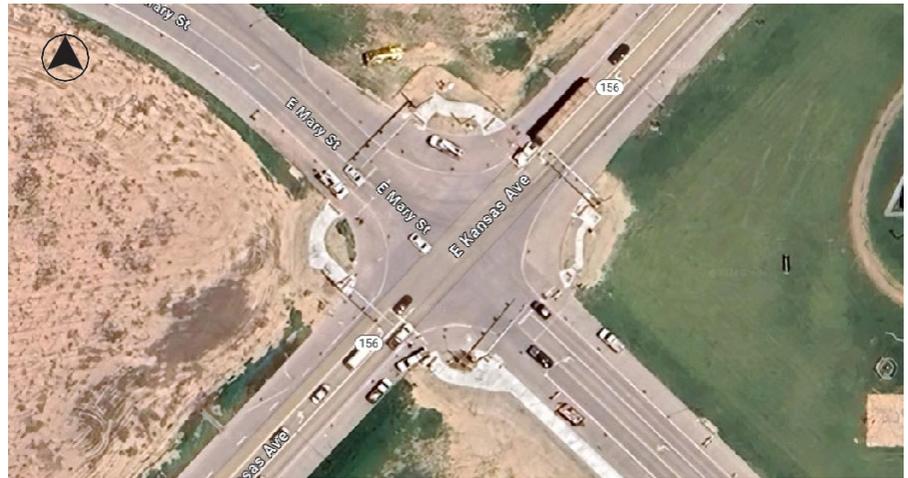
Figure 55 - Aerial Image of Kansas Avenue Intersection

The Mary Street and Kansas Avenue intersection was recently signalized (Figure 55). Prior to June 2023, the intersection was unsignalized. Prior to 2022, the intersection was TWSC with stop control on Mary Street & Jennie Barker Road. From January 2022 to June 2023, the intersection was an all-way stop. Mary Street ends at the intersection and continues as Jennie Barker Road to the east. All four legs

include a dedicated left-turn lane and two through lanes. Right-turns must be made from the shared through lane in all directions. There is protected/permissive left-turn phasing for every approach. The signal features the only flashing yellow arrows in the Garden City area.

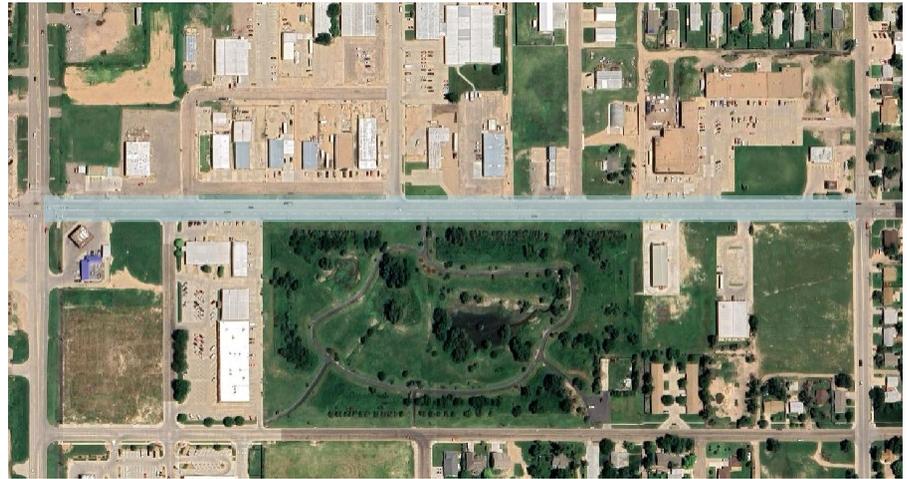
Figure 57 - Aerial Image of Taylor Avenue/ U.S. 83B to 8th Street

The Mary Street segment from Taylor Avenue/ U.S. 83B to 8th Street is a four-lane road with no dedicated turn lanes (Figure 57) and is 0.47 miles long. The area comprises commercial and recreational land uses and one residential lot. Forest Park Lake Wildlife Habitat is to the south of the segment and offers a small lake and an extensive trail loop that connects to the Talley Trail system.

There are 3-foot attached sidewalks present, with power poles running along the outside edge of the sidewalks on both sides of Mary Street. The daily traffic volume for this section of Mary Street is 8,200 to 9,900 VPD.

- Add/Repair stop lines on side streets

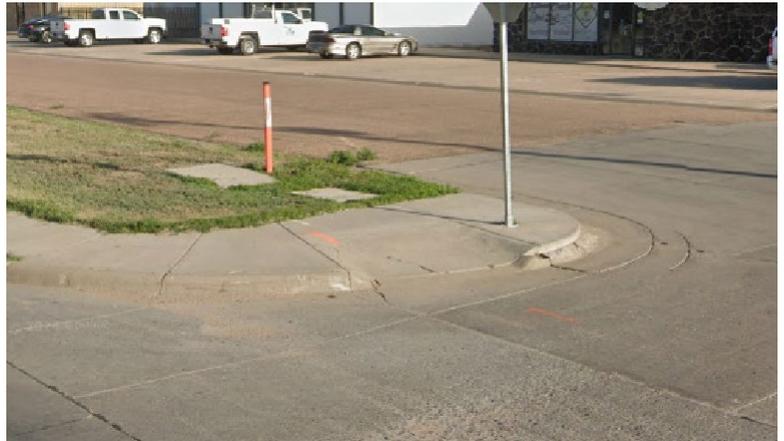
Figure 60 - Photo of Mary Street showing no truncated domes on curb ramp

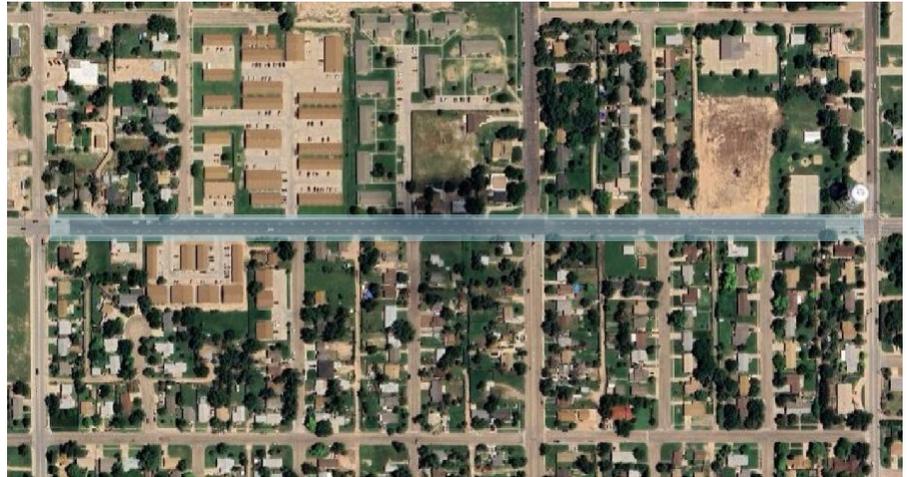
Figure 61 - Aerial Image of 8th Street to 3rd Street

The Mary Street segment from 8th Street to 3rd Street is a four-lane road with no dedicated turn lanes (Figure 61) and is 0.5 miles long. The area comprises low—and medium-density residential land uses. The west end of the segment consists of small one-story apartments on either side of Mary Street, while the rest are single-family homes. There is also a Sunni Islam Mosque on the south side of Mary Street.

There are 3-foot attached sidewalks on the south side of the street and detached on the north side, with power poles running along the outside edge of the sidewalks on both sides of Mary Street. There are no bike lanes or paths along Mary Street. The daily traffic volume for this section of Mary Street is approximately 11,400 VPD.

- Add/repair stop lines on side streets
- Bring the B Street crosswalk into MUTCD compliance
- Repair and reconstruct sidewalks
- Install curb ramps
- Move or remove the obstructions in the sidewalk

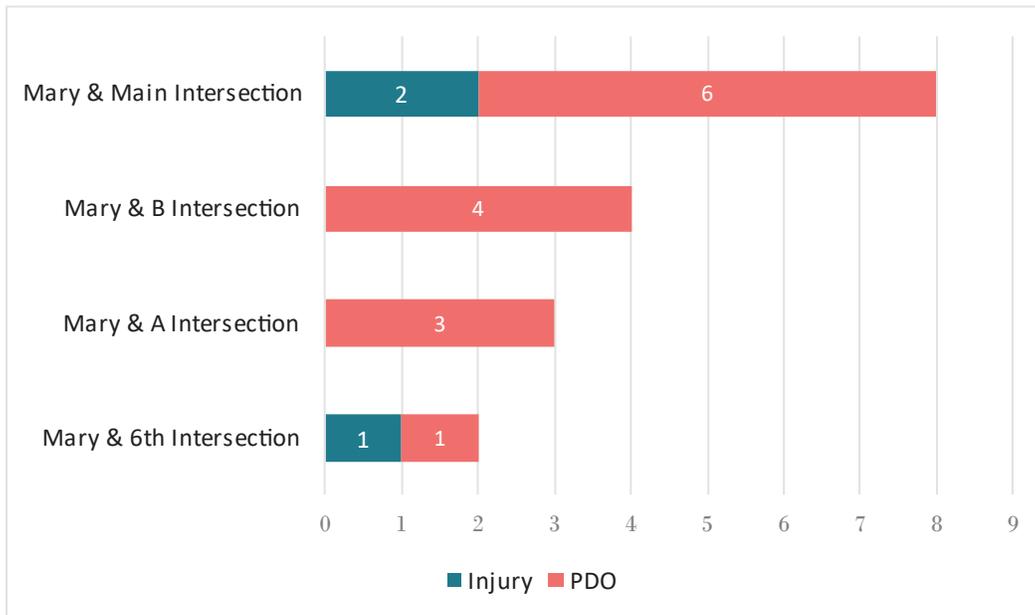
Figure 63 - Crashes at unsignalized intersections between 8th Street and 3rd Street

Figure 63 summarizes crashes between 8th Street and 3rd Street at unsignalized intersections. The intersections with Main Street (8) and B Street (4) saw the most crashes in the segment. The Main Street is a four-way intersection and is the only one on this segment that is not offset on the other side of Mary Street. Rear end crashes are the most common crash type at the Main Street intersection and account for both of the injury crashes.

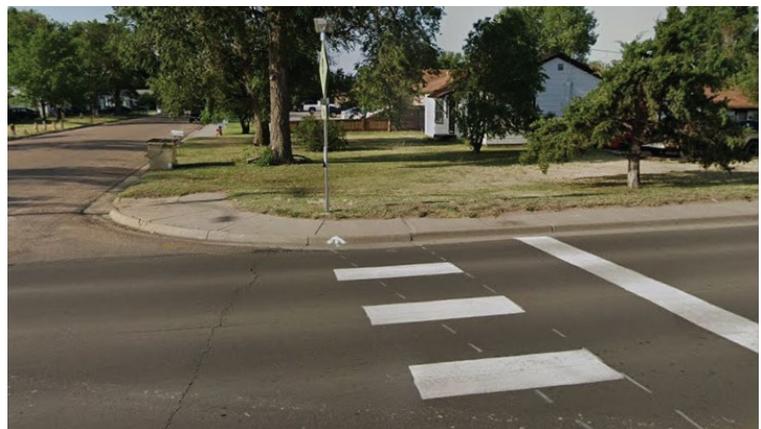
Figure 64 - Photo of Mary Street showing a lack of curb ramps & Yield Here for Pedestrian signs

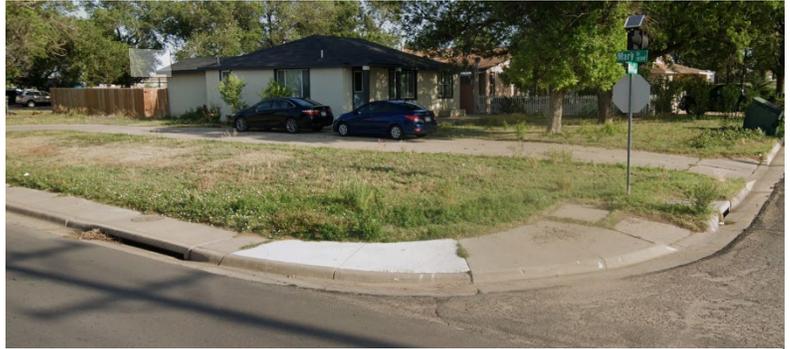
Figure 65 - Photo of Mary St and Main St showing a lack of truncated domes at curb ramps

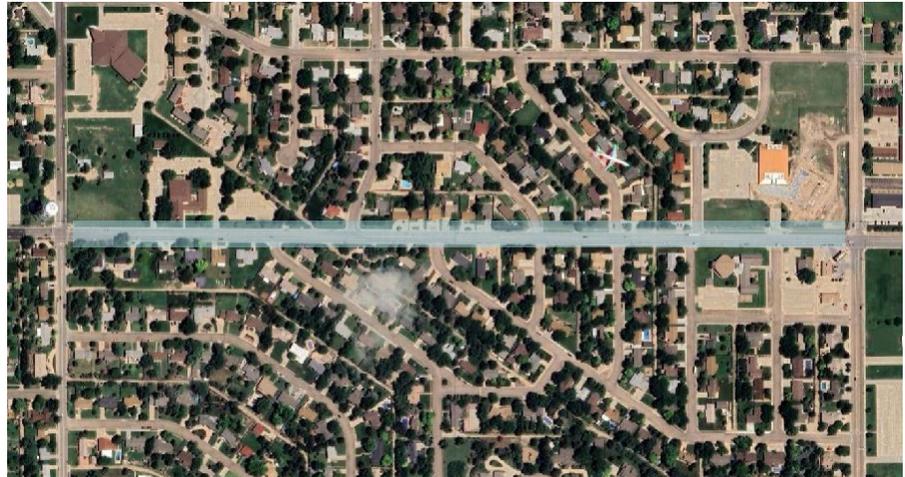
Figure 66 - Aerial Image of 3rd Street to Fleming Street

The Mary Street segment from 3rd Street to Fleming Street is a four-lane road with no dedicated turn lanes (Figure 66) and is 0.63 miles long. It is mostly comprised of low-density residential land uses, with a few areas designated for neighborhood shopping districts.

There are 3-foot attached sidewalks present, with power poles running along the outside edge of the sidewalks on both sides of Mary Street. The daily traffic volume for this section of Mary Street is approximately 11,900 VPD.

- Add/repair stop lines on side streets
- Move or remove the obstructions in the sidewalk

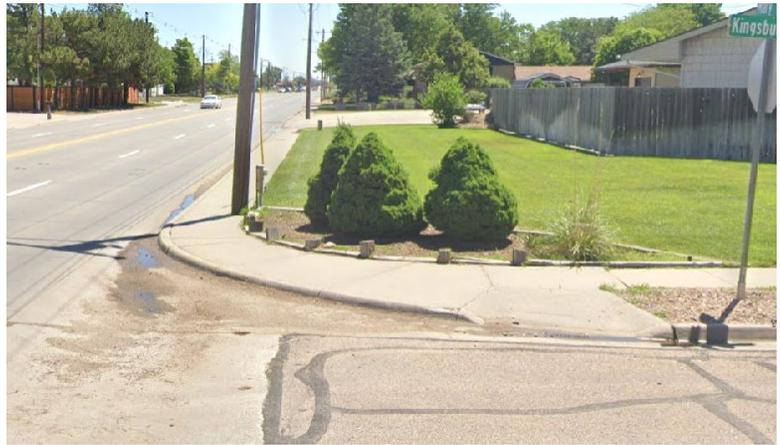
Figure 69 - Photo of Mary Street showing a lack of truncated domes on curb ramps
