Garden City Road Safety Audit

Mary Street: Taylor Avenue/U.S. 83B to Kansas Avenue

WILSON
& COMPANY

March 2025

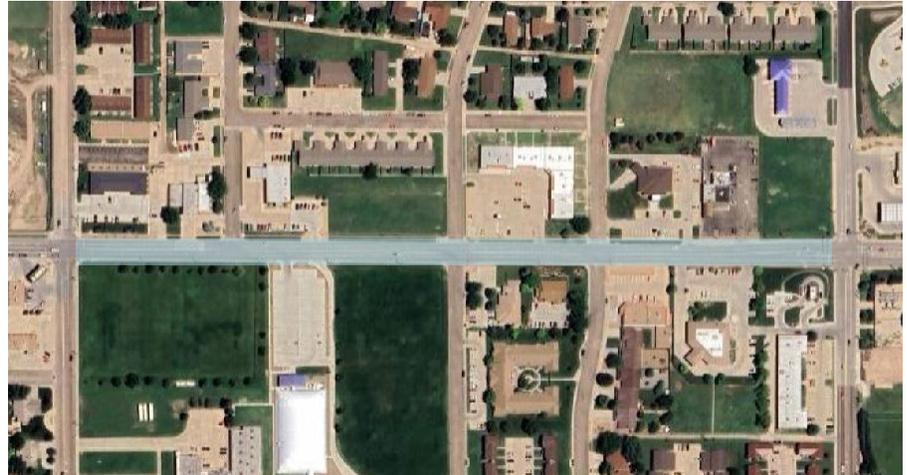
Figure 70 - Aerial Image of Fleming Street to Campus Drive

The Mary Street segment between Fleming Street and Campus Drive is a four-lane road with no dedicated turn lanes (Figure 70) and is 0.37 miles long. It comprises commercial land uses, including strip malls and various types of offices. In the southeast corner of the Mary Street/Fleming Street intersection is the Martin Esquivel Soccer Complex.

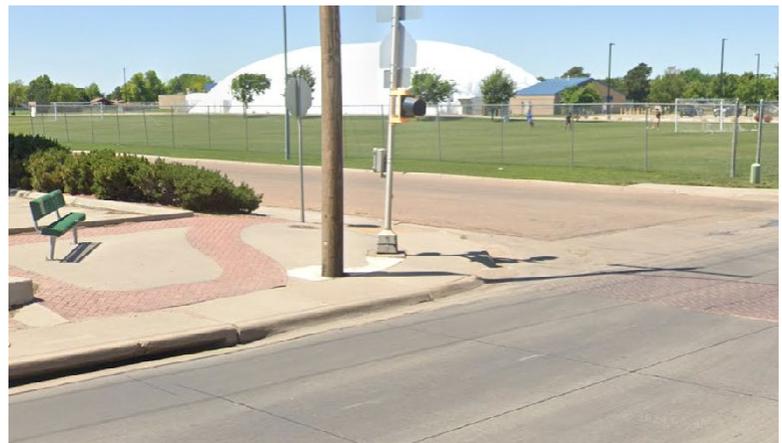
Figure 73 - Photo of Mary Street showing a lack of truncated domes at curb ramps

- There are no stop lines at side street intersections.
- Truncated domes are missing where curb ramps are present along the segment (Figure 68).

- Add/repair stop lines on side streets

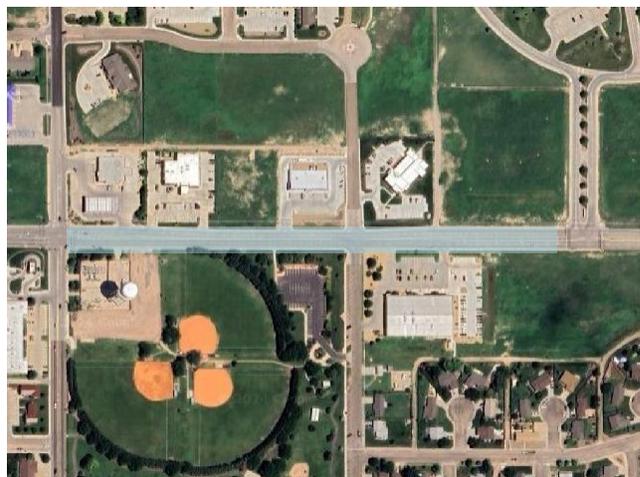
Figure 74 - Aerial image of Mary Street from Campus Drive to Buffalo Way Boulevard

The Mary Street segment from Campus Drive to Buffalo Way Boulevard is a four-lane road with no dedicated turn lanes, other than at signalized intersections (Figure 74) and is 0.32 miles long. Along this segment are commercial, recreational, and residential land uses, with connection to the Garden City High School to the north.

There are 3-foot attached sidewalks present, with power poles running along the outside edge of the sidewalks on both sides of Mary Street. The daily volume for this section of Mary Street is approximately 11,350 vpd.

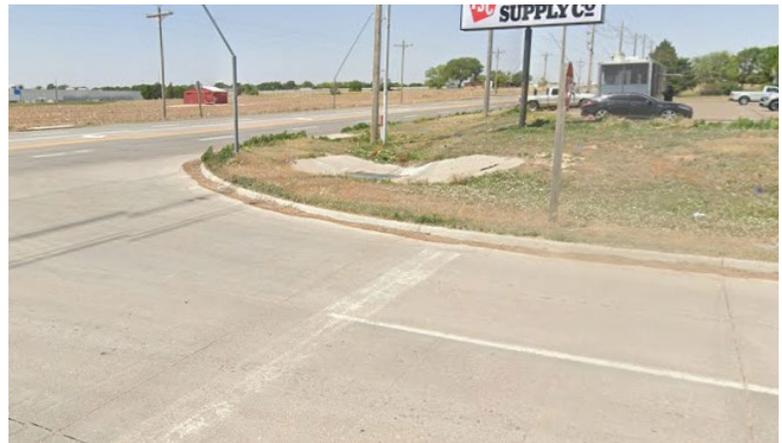
Figure 79 - Image of faded stop lines at Jennie Barker Road intersection

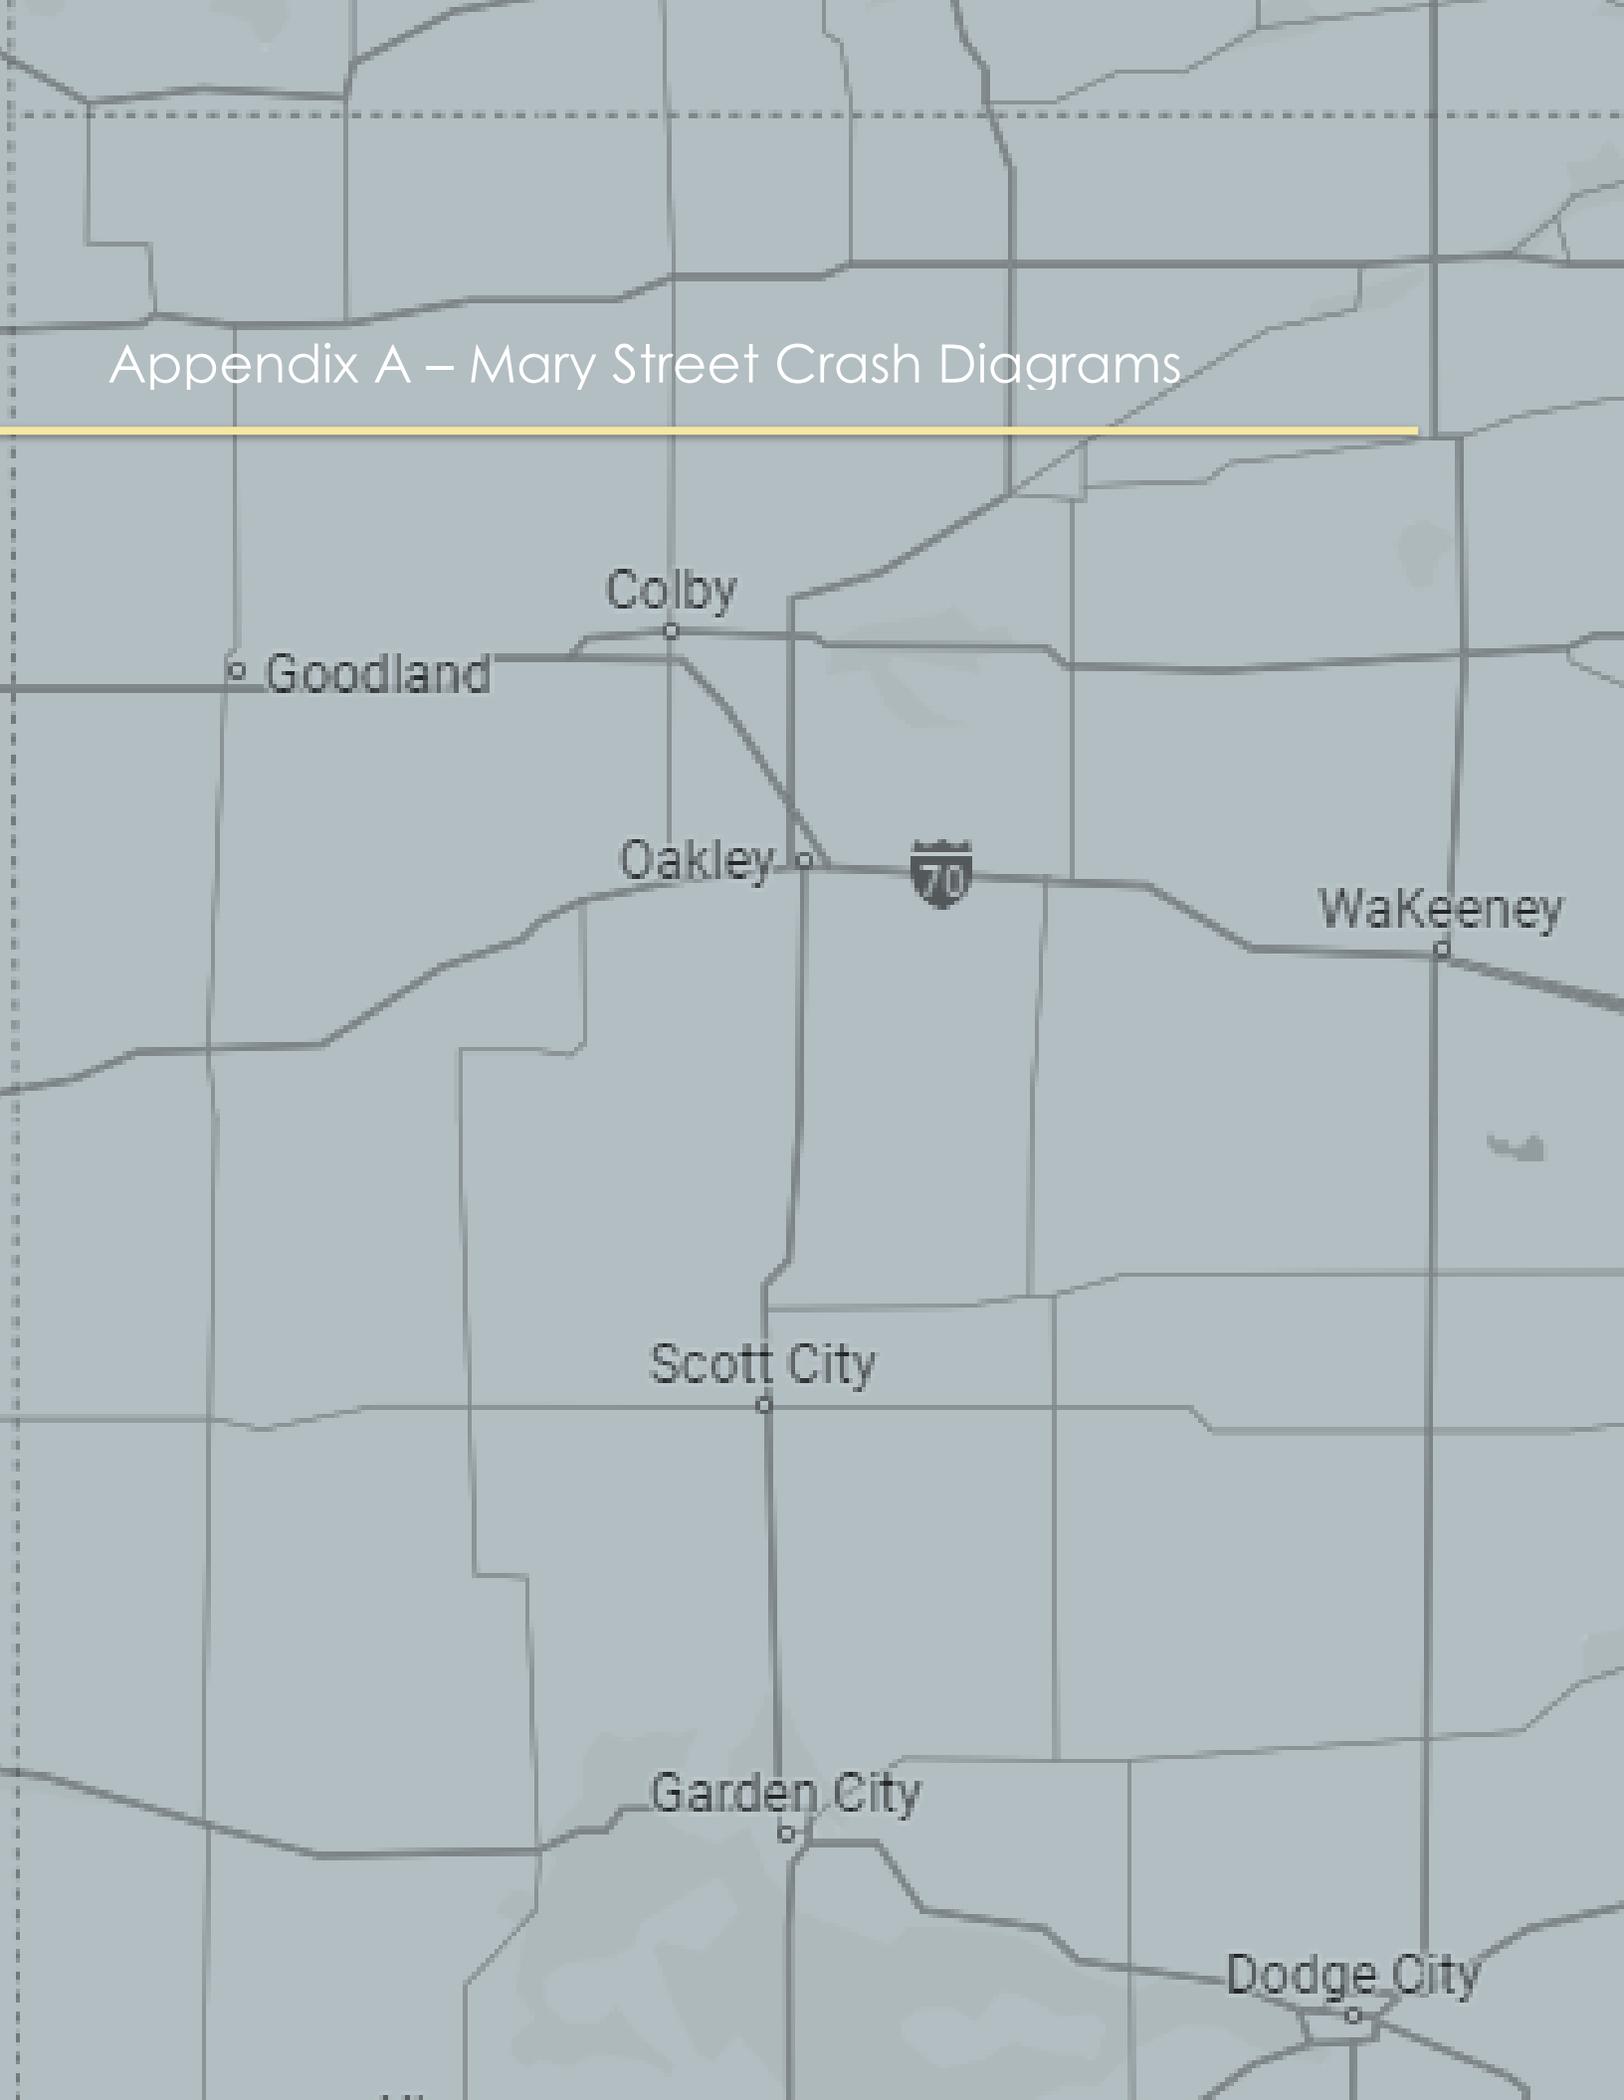
N Taylor Ave & W Mary St - Collision Diagram

Crash Data Collected : 2018 - 2022

Collision Types	Crash Severity		Total
	INJ	PDO	
Fixed Object	0	1	1
Angle - Avoidance Maneuver	0	1	1
Angle - Left Turn	1	1	2
Angle - Straight/ Following Road	1	2	3
Backed Into	0	1	1
Head On	0	2	2
Rear End	2	7	9
Sideswipe	0	1	1
Unknown	0	1	1
Total	4	17	21

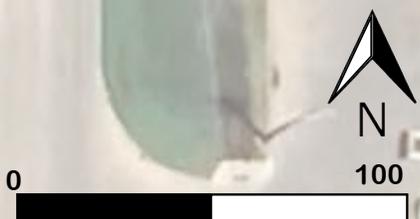
N 8th St & W Mary St - Collision Diagram

Crash Data Collected : 2018 - 2022

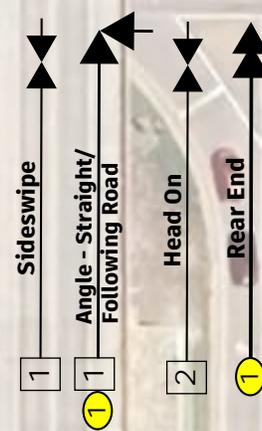
Jennie Barker Rd, Kansas Ave, & E Mary St - Collision Diagram

Collision Types	Crash Severity				Total
	Fatal	SSI	INJ	PDO	
Fixed Object	0	0	0	1	1
Angle - Left Turn	0	0	2	1	3
Angle - Right Turn	0	0	0	1	12
Angle - Straight/Following Road	1	1	1	2	5
Head On	0	0	0	2	2
Rear End	0	0	2	1	3
Sideswipe	0	0	0	1	1
Total	1	1	5	9	16
