Garden City Road Safety Audit

Kansas Avenue: Taylor Avenue/U.S. 83B to Jennie Barker Road

Prepared by: **WILSON**
&COMPANY

March 2025

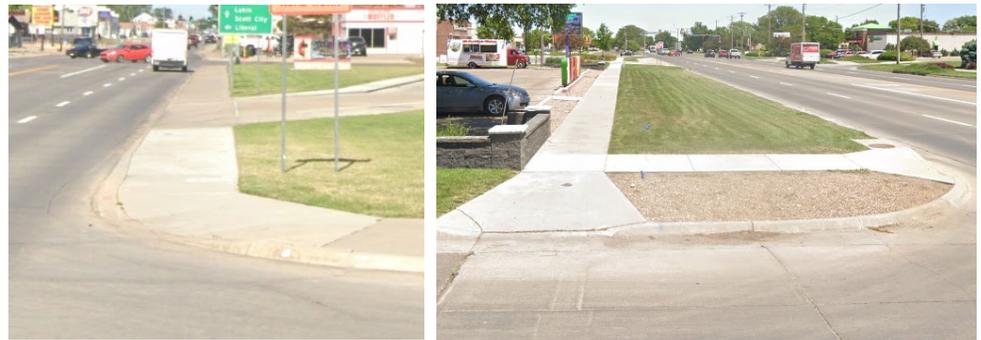
The existing sidewalks along Kansas Avenue are a mix of attached and detached, with widths ranging from approximately 3 to 5 feet, similar to the appearance shown in Figure 12. The sidewalk along the north side of Kansas Avenue between 3rd Street and Center Street, and between Fleming Street and Campus Drive is located along the north edge of the frontage road (Kansas Plaza), which is separated from the main roadway by a median (Figure 13).

Figure 12 - Photos showing examples of attached (left) and detached (right) sidewalks along Kansas Avenue

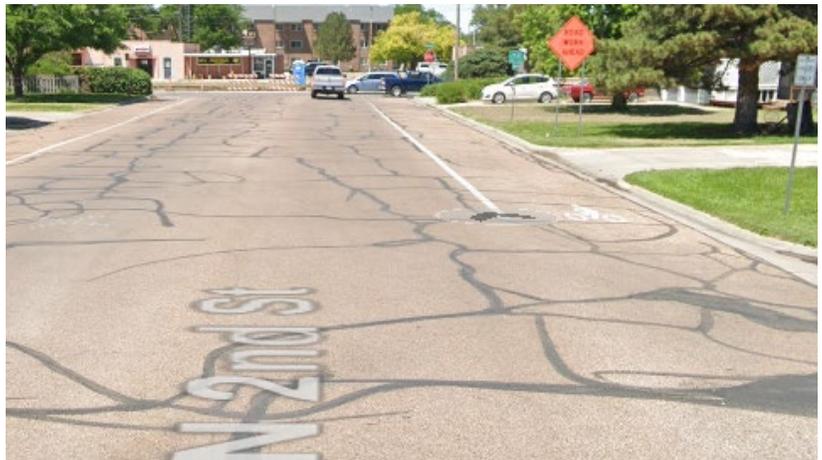
Figure 15 - Photo of bike lane on 2nd Street

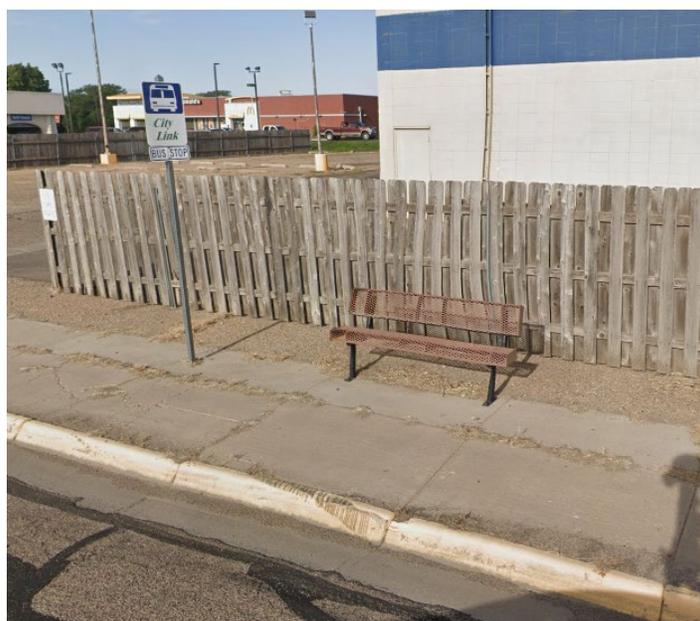
Figure 18 - Image of City Link bus stop at DCF off Kansas Avenue

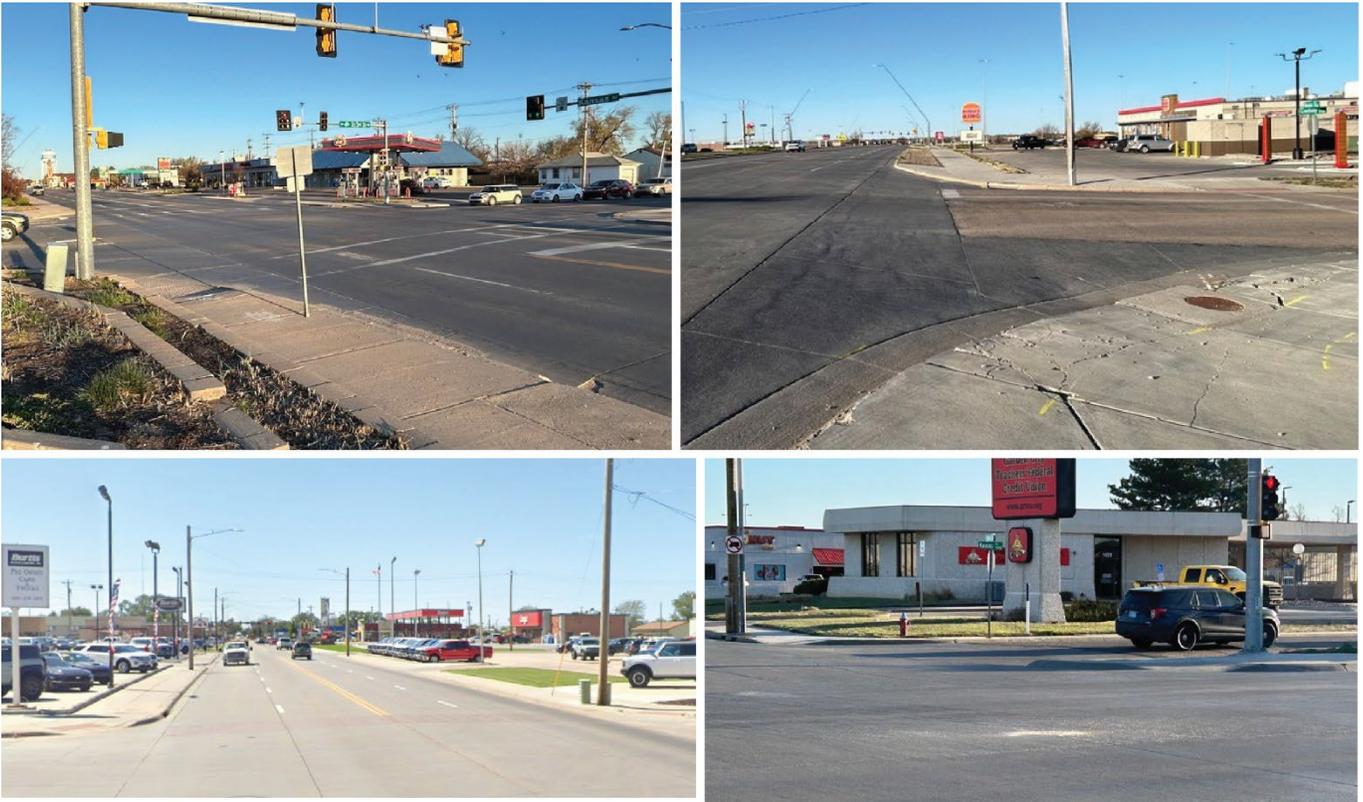
Figure 26 - General Observations on Kansas Avenue

- Several curb ramps along Kansas Avenue are missing truncated domes (Figure 26).
- Several locations had non-ADA-compliant curb ramp grades and landing areas.
- The use of pedestrian countdown signals was inconsistent at intersections along the corridor.
- Several segments of sidewalk along Kansas Avenue are blocked by objects such as power poles and street signs (Figure 26).

Recommendation: While installation of curb ramps at all locations along the corridor currently lacking and fixing non-compliant ramps and sidewalk infrastructure would be ideal, we recognize such a recommendation could be made for most any street corridor in the City. Therefore, we recommend installing or upgrading ramps with alterations of the street, curb, or sidewalk as already required by ADA regulations, as well as when identified as barriers by the public and as prioritized in a Transition Plan.

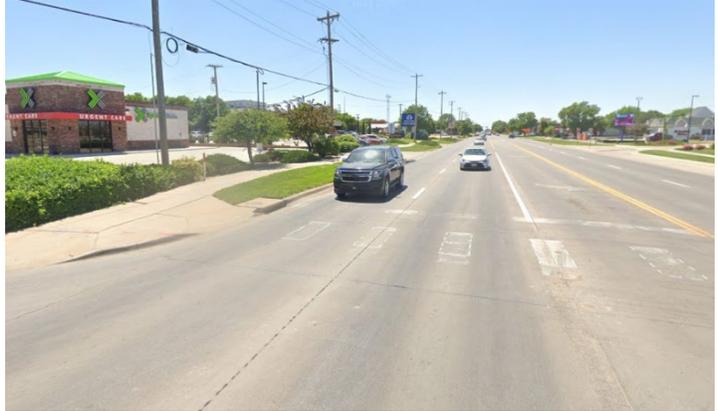
Figure 27 – Example of faded crosswalk that needs to be repainted

- There are several locations where crosswalk striping is missing or needs to be repainted (Figure 27).
- Most unsignalized intersections do not have stop lines at Mary Street.
 - The 11th edition of the *Manual on Uniform Traffic Control Devices (MUTCD)* states: "Stop lines may be used to indicate the point behind which vehicles are required to stop in compliance with a STOP (R1-1)

Recommendations: Evaluate existing pavement markings and as needed, restripe the corridor, including crosswalks and stop lines at signalized intersections. Use high durability pavement markings that last several years rather than traffic paint requiring annual application.

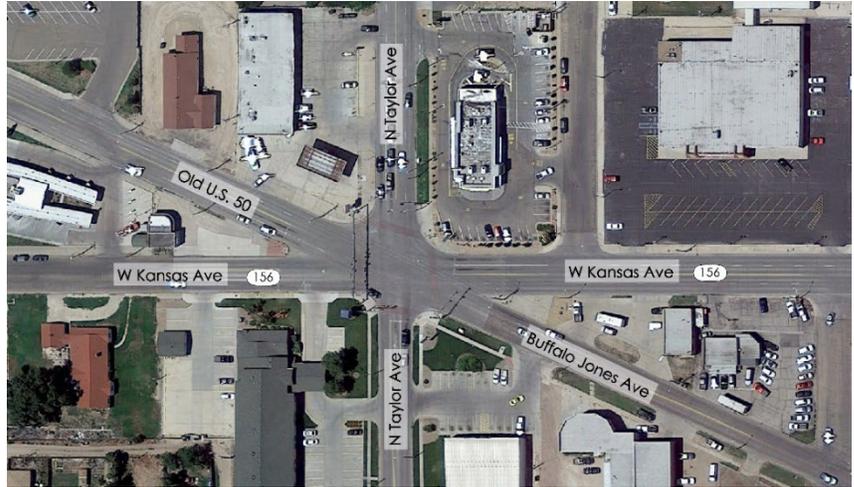
The Kansas Avenue and Taylor Avenue intersection is signalized with six approaches and represents the western boundary of the project study area, shown in Figure 31. Refer to Figure 32 to see the direction of travel for each lane approaching and leaving the intersection. Both approaches of Taylor Avenue have protected/permissive left-turn phasing, both approaches of Kansas Avenue have permissive-only left-turn phasing, and the Buffalo Jones (southeast-bound/northwest-bound) approaches are split phased (they “take turns” and do not run concurrently).

Figure 31 - Aerial Image of Taylor Avenue Intersection

A mix of attached and detached sidewalks are present on each leg of the intersection, except for at the tip of the medians between Kansas Avenue and Buffalo Jones Ave/Old U.S. 50, where there is no direct connection to the crosswalks. Brick crosswalks exist on all four sides of the intersection, each equipped with pedestrian signals, through none feature countdown timers.

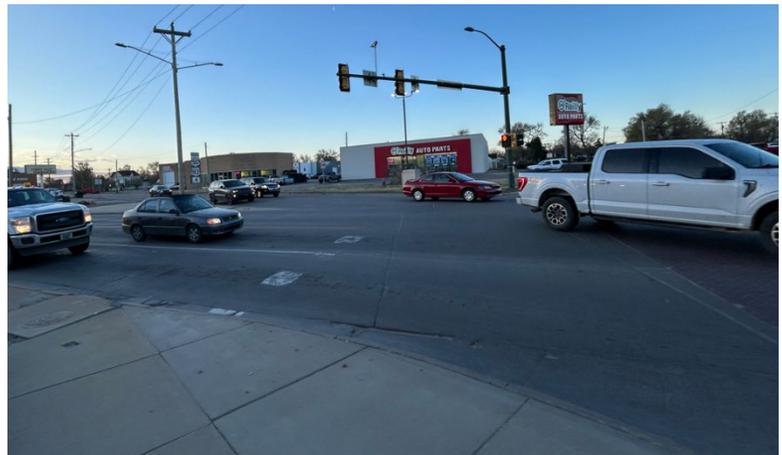
- The stop lines are faded/missing on all six legs of the intersection (Figure 35).

Figure 35 - Photo at Kansas Ave. & Taylor Ave intersection showing faded stop line

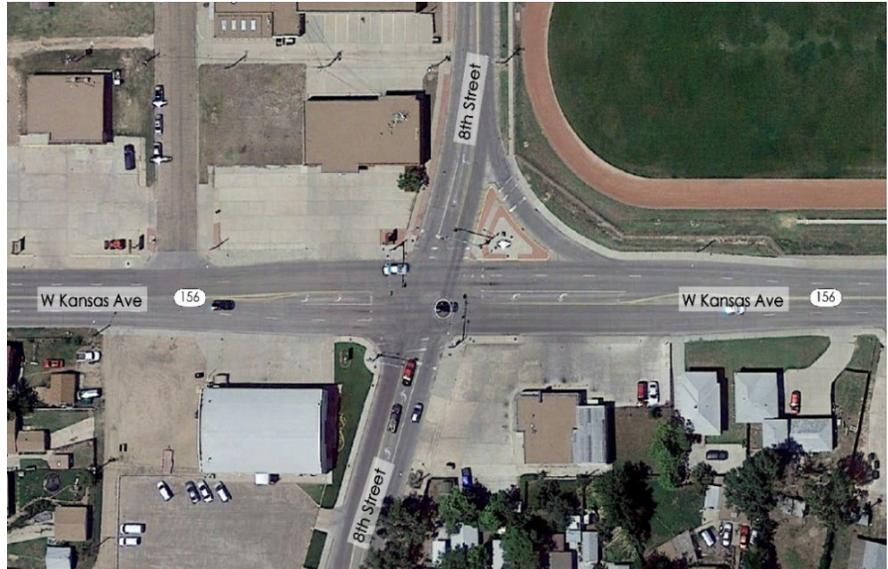
Kansas Avenue and 8th Street is a signalized intersection (Figure 38). The east leg of Kansas Avenue consists of two through lanes in each direction, a dedicated left-turn lane, and a channelized right-turn lane. The west leg of Kansas Avenue consists of two through lanes in each direction and a dedicated northbound left-turn lane. The north and south legs of 8th Street consist of a single through lane in each direction and a dedicated left-turn lane. Right-turns must be made from the right shared through lane on each approach except for the east leg of Kansas Avenue. There is protected/permissive left-turn phasing for every approach.

Figure 37 - Aerial Image of 8th Street Intersection

Attached sidewalks are present on every leg approaching the intersection. There are no bike lanes on Kansas Avenue or 8th Street. Daily traffic at the intersection is approximately 11,700 VPD on the west leg, 13,900 on the east leg, 5,500 VPD on the north leg, and 4,000 on the south leg. Ladder crosswalks are present on the north, south, and east sides of the intersection, each equipped with pedestrian signals, though none feature countdown timers. The 8th Street intersection saw 36 pedestrians and 4 bicyclists crossing the intersection over a 13-hour period. The east leg of the intersection saw the most bicycle and pedestrian crossings with 19 and there were no crossings on the west leg since it has no pedestrian signal phase.

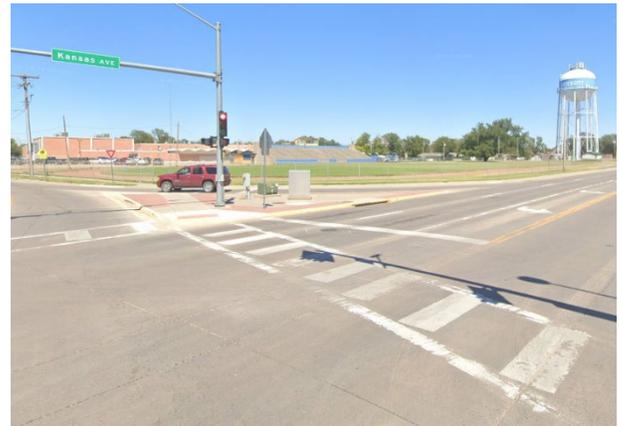
- The existing crosswalks on the north, east, and south legs of intersection were faded, but have since been refreshed (Figure 40).
- There is no marked crosswalk or pedestrian signal phase for the west leg of the intersection
- Pedestrian signals exist on the north, east, and south legs of the intersection but no countdown timers are present.
- In the channelized right turn lane, there is a stop line before the crosswalk marking and a yield sign past the crosswalk marking.

Figure 39 - Photo at Kansas Ave & 8th St showing faded crosswalk

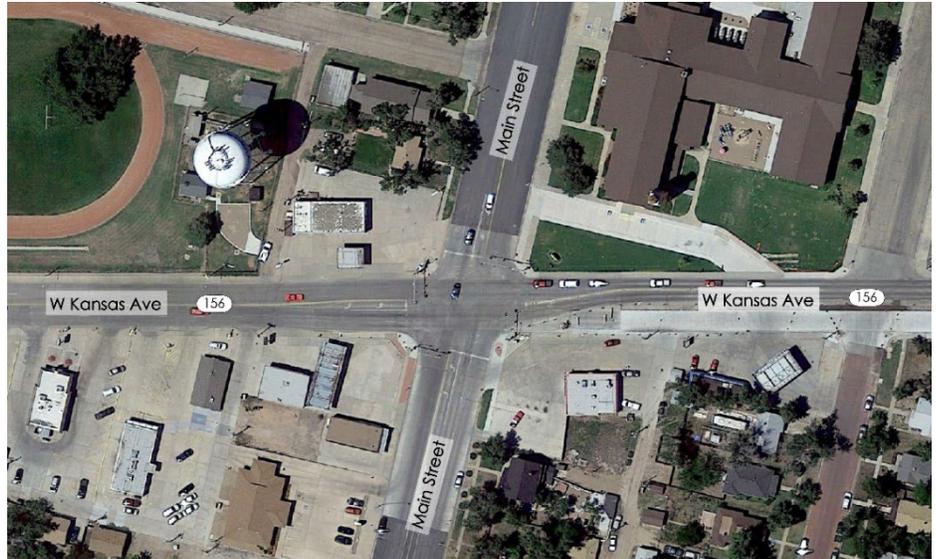
Kansas Avenue and Main Street is a signalized intersection (Figure 41). The east and west legs of Kansas Avenue consist of two through lanes in each direction and a dedicated left-turn lane. Right-turns must be made onto Main Street from the right shared through lane. The north and south legs of Main Street consist of a single through lane in each direction and dedicated left- and right-turn lanes onto Kansas Avenue. There is protected/permissive left-turn phasing for every approach.

Figure 40 - Aerial Image of Main Street Intersection

Attached sidewalks are present on every leg approaching the intersection. There are no existing bike lanes on Kansas Avenue or Main Street. A bike lane is proposed along Main Street north of Kansas Avenue. Daily traffic at the intersection is approximately 14,100 VPD on the west leg, 15,600 on the east leg, 4,400 VPD on the north leg, and 5,000 on the south leg. Continental crosswalks are present on all four sides of the intersection, each equipped with pedestrian signals and countdown timers. The Main Street intersection saw 31 pedestrians and 2 bicyclists crossing the intersection over a 13-hour period.

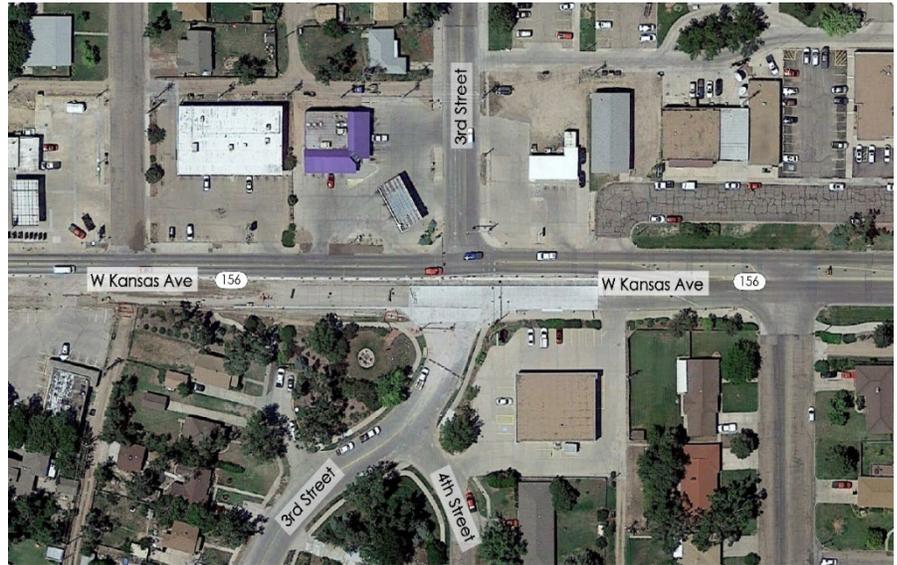
Kansas Avenue and 3rd Street is a signalized intersection (Figure 43). The east and west legs of Kansas Avenue consist of two through lanes in each direction and a dedicated left-turn lane. The north and south legs of 3rd Street consist of a single through lane in each direction and a dedicated left-turn lane. Right-turns must be made from the right shared through lane for every approach. There is protected/permissive left-turn phasing for every approach.

Figure 42 - Aerial Image of 3rd Street Intersection

A mix of attached and detached sidewalks are present on every leg approaching the intersection. There are no existing bike lanes on Kansas Avenue or 3rd Street. Daily traffic at the intersection is approximately 16,400 VPD on the west leg, 18,900 on the east leg, 6,200 VPD on the north leg, and 5,200 on the south leg. A mix of continental and ladder crosswalks are present on all four sides of the intersection, each equipped with pedestrian signals, though none feature countdown timers. The 3rd Street intersection saw 42 pedestrians and 8 bicyclists crossing the intersection over a 13-hour period.

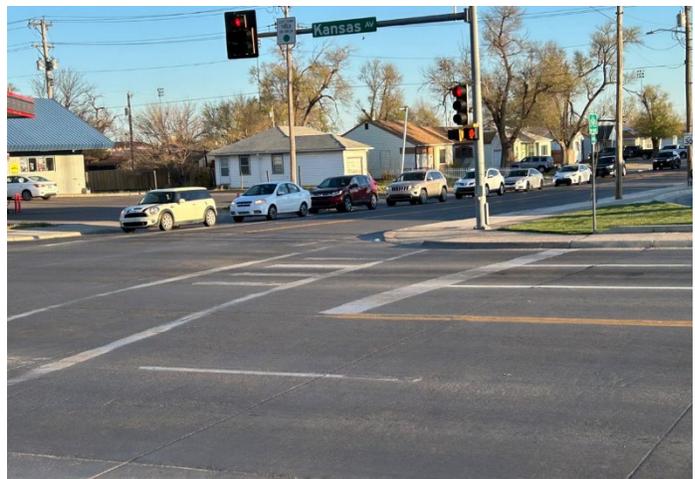
Figure 44 - Photo at Kansas Ave & 3rd St showing faded crosswalk and stop line

- The painted crosswalks and stop lines were faded on all four legs of the intersection (Figure 45).
- Three of the four curb ramps (NE, SE, and SW corners) do not have truncated domes.
- Landscaping on the southwest corner of intersection may be blocking the sight distance for northbound right turn vehicles.
- There are pedestrian signal heads at this intersection, but they do not have countdown timers.
- 4th Street curves up as it approaches Kansas Avenue so that it can align with 3rd Street at Kansas Avenue. The curve of the road may be blocking the view of southbound left turning vehicles yielding to oncoming northbound vehicles and northbound vehicles may have decreased perception when approaching the intersection. This may have contributed to some of the northbound rear end, fixed object, and angle crashes at this intersection due to reduced sight distance.

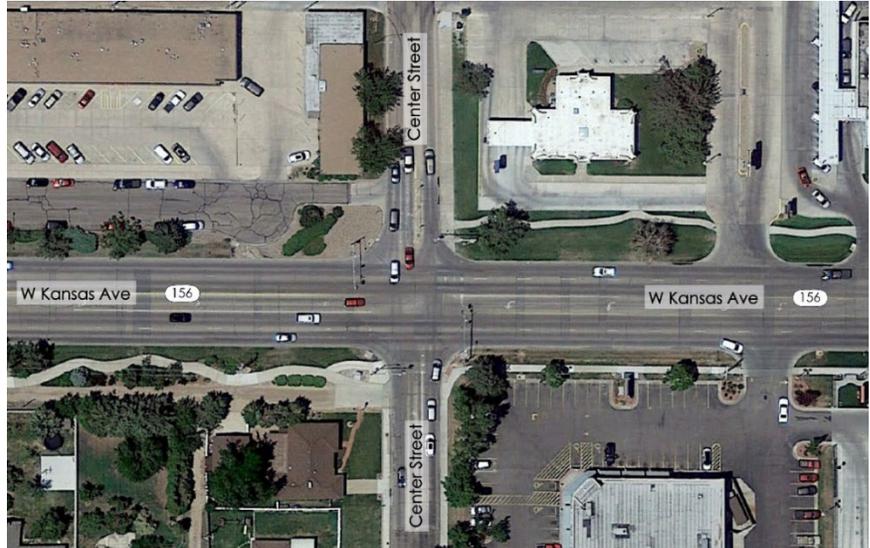
Kansas Avenue and Center Street is a signalized intersection (Figure 46). The east and west legs of Kansas Avenue consist of two through lanes in each direction and a dedicated left-turn lane. The north and south legs of Center Street consist of a single through lane in each direction and dedicated left-turn lane. Right-turns must be made from the right shared through lane for every approach. There is protected/permissive left-turn phasing for every approach.

Figure 45 - Aerial Image of Center Street Intersection

A mix of attached and detached sidewalks are present on every leg approaching the intersection except for along the west side of the north leg of Center Street. There are no existing bike lanes on Kansas Avenue or Center Street. Daily traffic at the intersection is approximately 19,400 VPD on the west leg, 19,600 on the east leg, 4,100 VPD on the north leg, and 2,300 on the south leg. Brick and standard crosswalks are present on the east and south sides of the intersection, both equipped with pedestrian signals and countdown timers. The Center Street intersection saw 42 pedestrians and 12 bicyclists crossing the intersection over a 13-hour period.

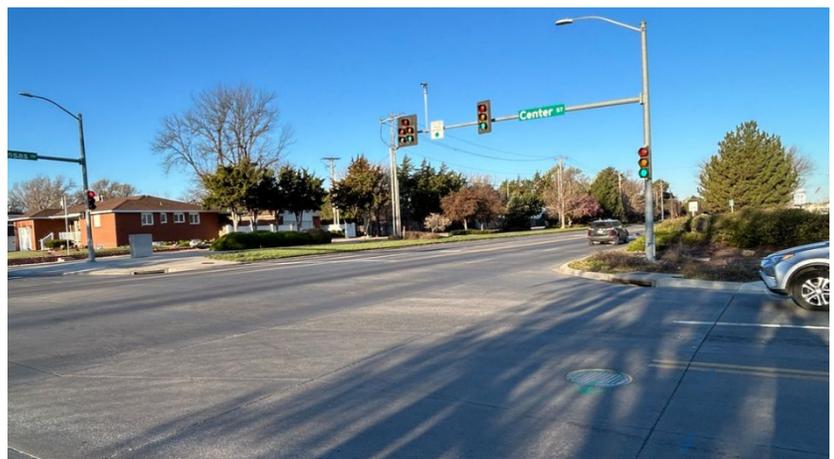
Figure 47 - Photo of Kansas Ave and Center St intersection showing faded stop line

- The curb ramp on the northwest corner of the intersection is missing truncated domes.

- The north leg of the intersection is missing a stop line (Figure 48).
- The stop lines on the north and south leg of the intersection were faded.
- The west and north legs of the intersection lack marked crosswalks and pedestrian signals.

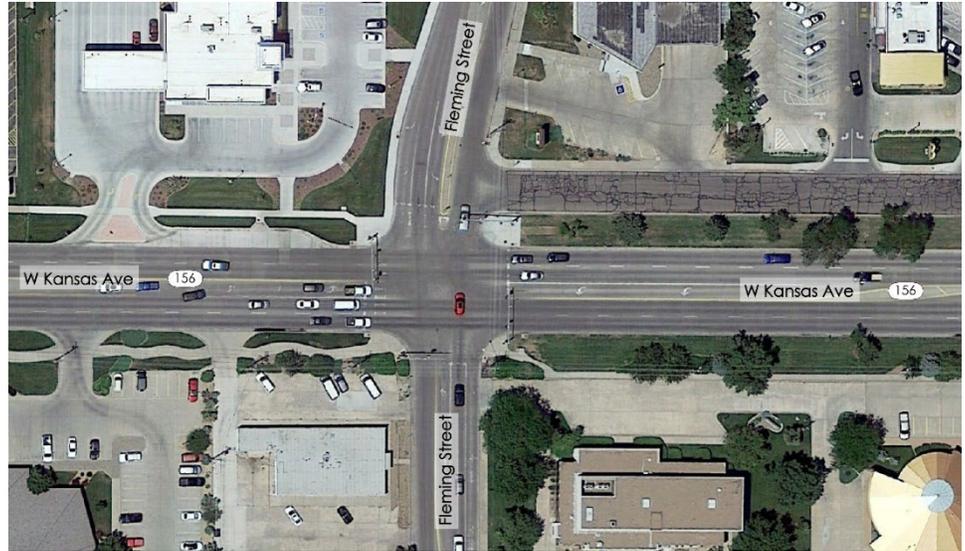
Kansas Avenue and Fleming Street is a signalized intersection (Figure 49). The east and west legs of Kansas Avenue consist of two through lanes in each direction and a dedicated left-turn lane. Right turns onto Fleming Street must be made from the right shared through lane onto Fleming Street. The north and south legs of Fleming Street consist of a single through lane in each direction and dedicated left- and right-turn lanes onto Kansas Avenue. There is protected/permissive left-turn phasing for every approach.

Figure 48 - Aerial Image of Fleming Street Intersection

A mix of attached and detached sidewalks are present on every leg approaching the intersection. There are no existing bike lanes on Kansas Avenue or Fleming Street. Daily traffic at the intersection is approximately 20,300 VPD on the west leg, 18,800 on the east leg, 7,300 VPD on the north leg, and 6,800 on the south leg. Continental crosswalks are present on all four sides of the intersection, each equipped with pedestrian signals, though none feature countdown timers. The Fleming Street intersection saw the most pedestrian activity at a signalized intersection on Kansas Avenue, with 48 pedestrians crossing the intersection over a 13-hour period. There were 2 bicyclist crossings during the same 13-hour period.

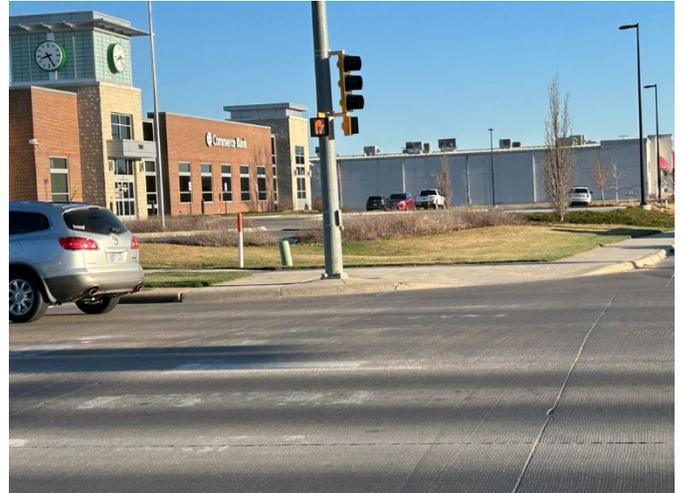
Figure 50 - Photo at Kansas Ave & Fleming St showing faded crosswalk and missing truncated domes

- The crosswalk across the frontage road to reach the intersection was faded.
- The crosswalks and stop lines on all four legs of the intersection were faded (Figure 51 **Error! Reference source not found.**).
- All four curb ramps at the intersection are missing truncated domes (Figure 51).
- Pedestrian signals exist but no countdown timers are present.

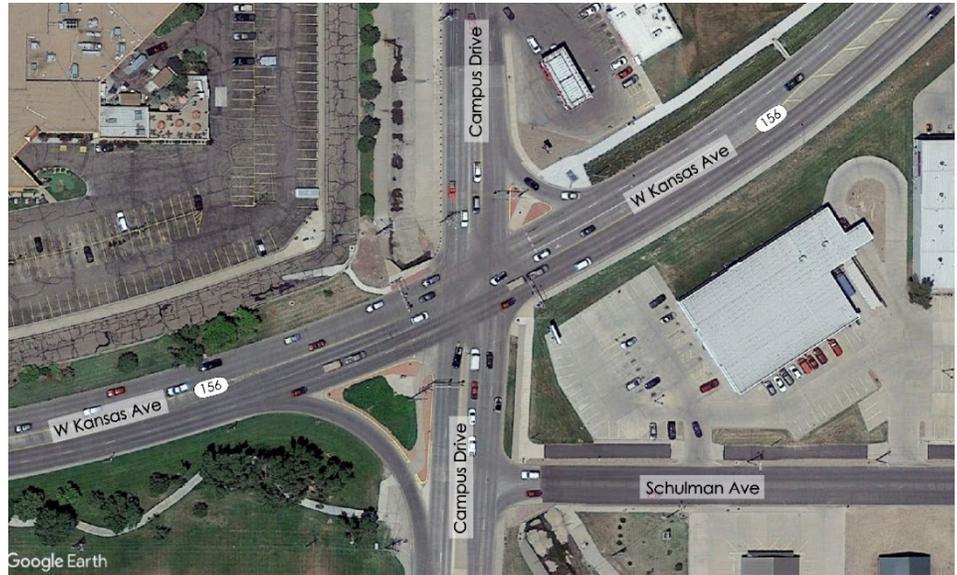
Kansas Avenue and Campus Drive is a signalized intersection. Schulman Avenue intersects Campus Drive just 180 feet south of Kansas Avenue (centerline-to-centerline spacing), with only right turns allowed to and from Schulman Avenue (Figure 52). The east and west legs of Kansas Avenue consist of two through lanes in each direction, a dedicated left-turn lane, and a channelized right-

Figure 51 - Aerial Image of Campus Drive Intersection

turn lane onto Campus Drive. The north leg of Campus Drive consists of two through lanes in each direction and a dedicated left-turn lane. Right-turns from the north leg of Campus Drive onto Kansas Avenue must be made from the right shared through lane. The south leg of Campus Drive consists of a single northbound through lane with dedicated left- and right-turn lanes and two southbound receiving lanes separated by a median. There is protected/permissive left-turn phasing for every approach. Schulman Avenue consists of a single through lane in each direction with right-in, right-out only access from/onto Campus Drive.

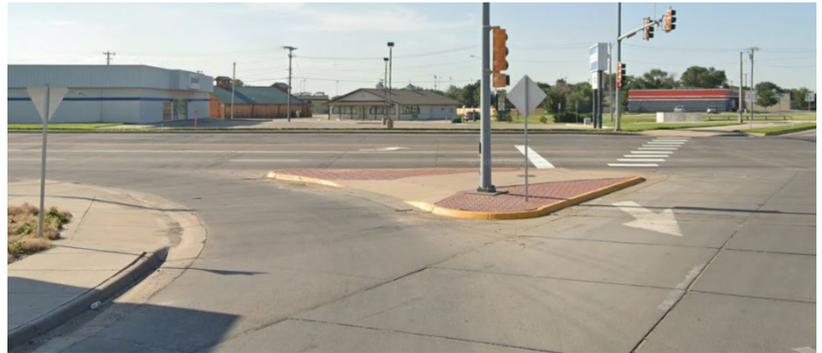
Figure 53 – Photo of Kansas Ave & Campus Dr showing missing pedestrian connection across channelized turning lane

- There is no marked crosswalk across the channelized turn lane to connect to the existing crosswalk on the east leg of the intersection (Figure 54).
- All curb ramps at the intersection are missing truncated domes.
- Pedestrian signals exist only on the east leg, but no countdown timers are present.
- There are no yield lines at the yield sign for either of the channelized turn lanes.
- There are obstructions on the Talley Trail to the north of the intersection.
- The north leg of the intersection has two receiving lanes and the outside lane merges into the inside lane
- Vehicle queues on the northbound approach can extend beyond the Schulman Avenue intersection.

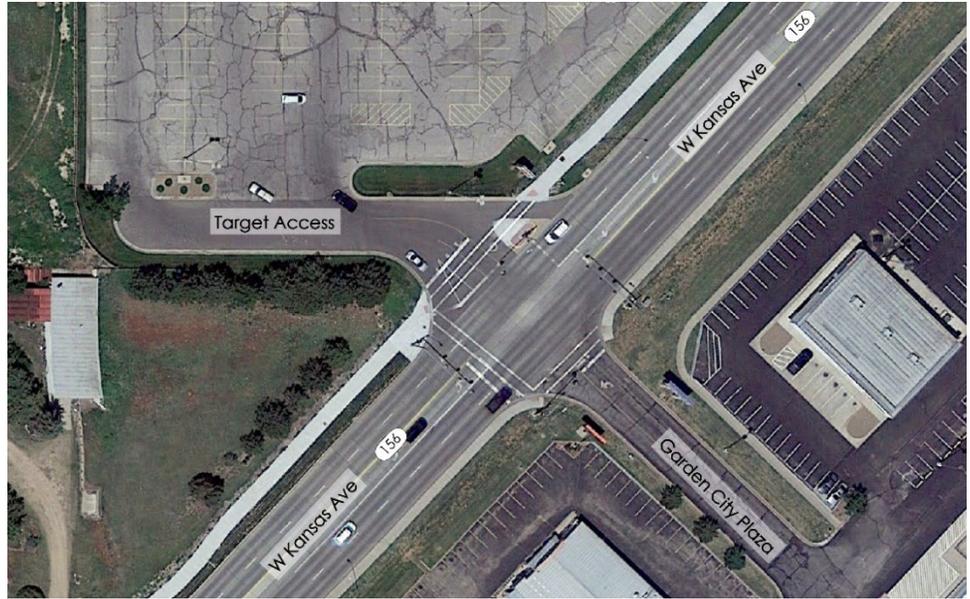
Kansas Avenue and the Target/Garden City Plaza Access points is a signalized intersection (Figure 56). The east leg of Kansas Avenue consists of two through lanes in each direction, a dedicated left-turn lane, and a channelized right-turn lane into Target. The west leg of Kansas Avenue consists of two through lanes in both directions and a dedicated left-turn lane. The north leg accessing Target consists of a single through lane in each direction and dedicated left- and right-turn lanes. The south leg accessing Garden City Plaza consists of a single through lane in each direction and a dedicated left-turn lane. Right-turns must be made from the right shared through lane on the west and south legs of the intersection. There is protected-only left-turn phasing for the east and west approaches and protected/permissive left-turn phasing for the north and south approaches.

Figure 55 - Aerial Image of Target/GC Plaza Access Intersection

Sidewalks are present along both sides of Kansas Avenue approaching the intersection and on the north side of Kansas Avenue the sidewalks are 10 feet wide. There are no sidewalks along the access drives for Target or Garden City Plaza. There are no existing bike lanes on Kansas Avenue or the access drives for Target and Garden City Plaza. Daily traffic at the intersection is approximately 12,100 VPD on the west leg, 11,900 on the east leg, 1,700 VPD on the north leg, and 1,100 on the south leg. Standard crosswalks with pedestrian signals and countdown timers are present on the north, south, and west legs of the intersection. The Target/Garden City Plaza intersection saw 19 pedestrians and 3 bicyclists crossing the intersection over a 13-hour period, which included some crossings of the east leg despite its lack of a marked/signalized crosswalk.

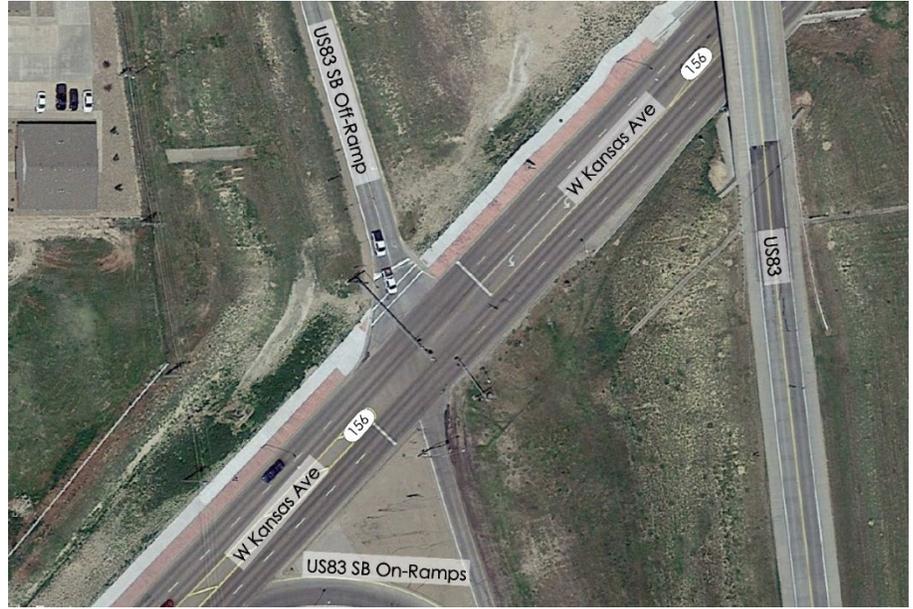
Figure 58 - Aerial Image of U.S. 83 Southbound On/Off-Ramps Intersection

Kansas Avenue runs underneath U.S. 83, resulting in a grade separation that requires on- and off-ramps for access. The intersection of Kansas Avenue and the southbound on- and off-ramps of U.S. 83 is a signalized intersection (Figure 59). The east leg of Kansas Avenue consists of two through lanes in each direction and a dedicated left-turn lane onto the U.S. 83 Southbound on-ramp. The west leg of Kansas Avenue consists of two through lanes in each direction separated by a flush median marking with a channelized right-turn lane onto the the U.S. 83 Southbound on-ramp. The north leg of the intersection consists of the U.S. 83 Southbound off-ramp which has dedicated left- and right-turn lanes. The south leg of the intersection consists of the U.S. 83 Southbound on-ramp which has a single lane. All turning movements at this intersection occur via dedicated turning lanes. The eastern approach has protected/permissive left-turn phasing and the northern leg has permitted turning movements.

Attached sidewalks are present along the north side Kansas Avenue approaching the intersection but are absent along the south side. There are no sidewalks along the U.S. 83 on- and off-ramps. There are no existing bike lanes on Kansas Avenue or the U.S. 83 ramps. Daily traffic at the intersection is approximately 11,700 VPD on the west leg, 11,000 on the east leg, 1,600 VPD on the north leg, and 2,500 on the south leg. A standard crosswalk with pedestrian signals and countdown timers is present on the north leg of the intersection. The U.S. 83 Southbound ramps intersection saw 9 pedestrians and 4 bicyclists crossing the intersection over a 13-hour period. Despite the lack of pedestrian infrastructure, two pedestrians were counted crossing the south leg of the intersection.

Specific recommendations for the Kansas Avenue and U.S. 83 Southbound ramp intersection include:

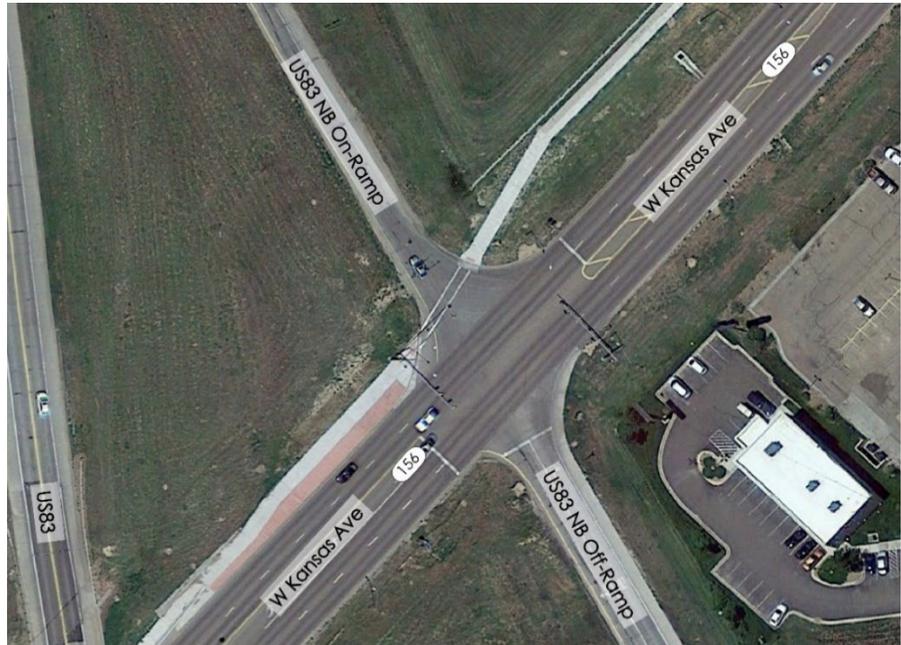
Figure 60 - Aerial Image of U.S. 83 Northbound On/Off-Ramps Intersection

Kansas Avenue runs underneath U.S. 83, resulting in a grade separation that requires on- and off-ramps for access. The intersection of Kansas Avenue and the northbound on- and off-ramps of U.S. 83 is a signalized intersection (Figure 61). The east leg of Kansas Avenue consists of two through lanes in each direction separated by a flush median marking. Right-turns onto the U.S. 83 Northbound on-ramp must be made from the right shared through lane. The west leg of Kansas Avenue consists of two through lanes in each direction with a dedicated left-turn lane onto the the U.S. 83 Northbound on-ramp. The north leg of the intersection consists of the U.S. 83 Northbound on-ramp which consists of a single lane. The south leg of the intersection consists of the U.S. 83 Northbound off-ramp which consists of a dedicated right-turn lane and a straight or left-turn lane. The western approach has protected/permissive left-turn phasing and the southern leg has permitted turning movements.

Attached and detached sidewalks are present along the north side Kansas Avenue approaching the intersection but are absent along the south side. There are no sidewalks along the U.S. 83 on- and off-ramps. There are no existing bike lanes on Kansas Avenue or the U.S. 83 ramps. Daily traffic at the intersection is approximately 11,100 VPD on the west leg, 11,300 on the east leg, 1,600 VPD on the north leg, and 1,800 on the south leg. Pedestrian signals with countdown timers exist on the north leg of the intersection but no pavement markings are present. The U.S. 83 Northbound ramps intersection saw 8 pedestrians and 4 bicyclists crossing the intersection over a 13-hour period. Despite the lack of pedestrian infrastructure, two pedestrians were counted crossing the south leg of the intersection.

Specific recommendations for the Kansas Avenue and U.S. 83 Northbound ramp intersection include:

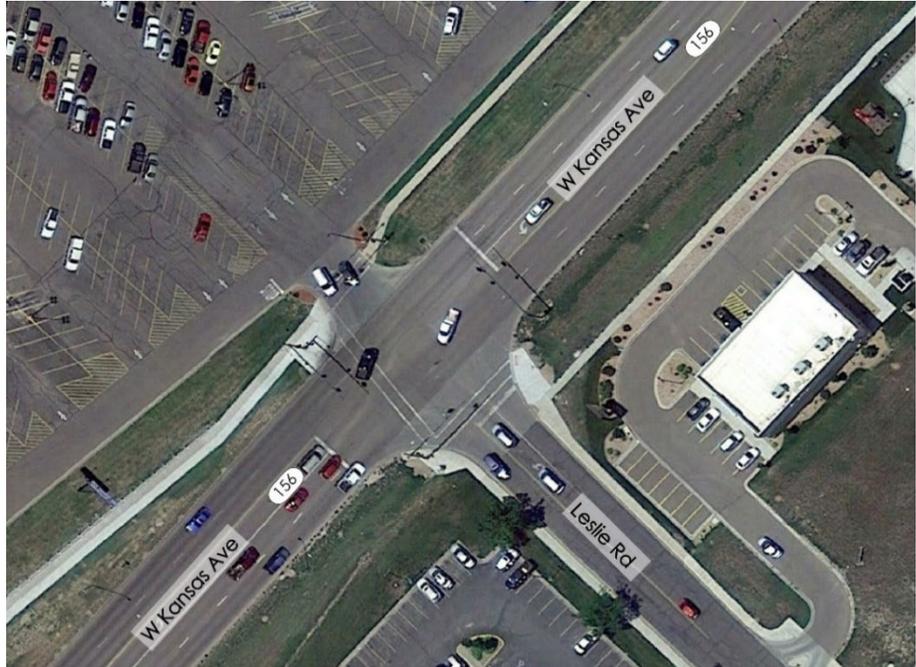
Figure 62 - Aerial Image of Leslie Road Intersection

Kansas Avenue and Leslie Road is a signalized intersection (Figure 63). The east and west legs of Kansas Avenue consist of two through lanes in each direction and a dedicated left-turn lane. The north leg of Leslie Road feeds into the Walmart parking lot and consists of a single through lane in each direction and a dedicated left-turn lane. The south leg of the Leslie Road consists of a single through lane in each direction and a dedicated left-turn lane. Right-turns must be made from the right shared through lane for every approach. There is protected/permissive left-turn phasing for every approach.

A mix of attached and detached sidewalks are present on the east, south, and west legs of the intersection. There are no existing bike lanes on Kansas Avenue or Leslie Road. Daily traffic at the intersection is approximately 11,200 VPD on the west leg, 5,100 on the east leg, 4,200 VPD on the north leg, and 6,600 on the south leg. A mix of standard and ladder crosswalks are present on the north, south, and west sides of the intersection, all equipped with pedestrian signals and countdown timers. The Leslie Road intersection saw 27 pedestrians and 4 bicyclists crossing the intersection over a 13-hour period.

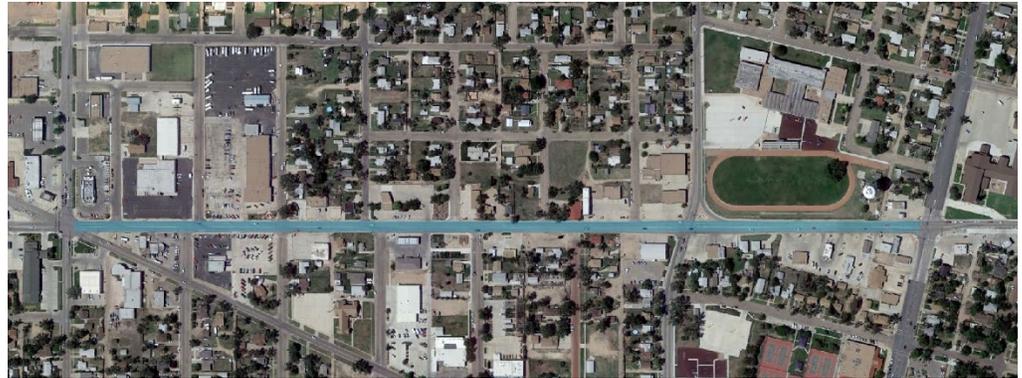
Figure 65 - Aerial View of Kansas Ave between Taylor Avenue/U.S. 83B & Main Street

The Kansas Avenue segment from Taylor Avenue/U.S. 83B to Main Street is a four-lane road with no dedicated turning lanes (Figure 66) and is 0.65 miles long. The area directly adjacent to Kansas Avenue comprises commercial land uses with a few residential

lots mixed in. The commercial activity along this segment varies including auto parts stores, car dealerships, gas stations, and a variety of locally-owned businesses. Abe Hubert Elementary School is located on the north side of Kansas Avenue at the intersection with 8th Street. Residential land uses are present to both the north and south beyond the commercial land uses that are directly adjacent to Kansas Avenue.

There are 5-foot attached sidewalks on the north side of the street and between 13th St to 10th St and 8th St to Main St on the south side of the street. The south side of the street is missing sidewalks between Taylor Avenue/U.S. 83B to 13th St and between 10th St and 8th St. There are some obstructions in the sidewalks on both sides of the street including power/street light poles, street signs, etc. There are two unsignalized crosswalks in this segment across Kansas Ave at 11th and 12th Streets. There are no bike lanes or paths along Kansas Avenue. The daily traffic volume for this section of Kansas Avenue is approximately 11,700 VPD.

Specific recommendations for the segment of Kansas Avenue from Taylor Avenue to Main Street include:

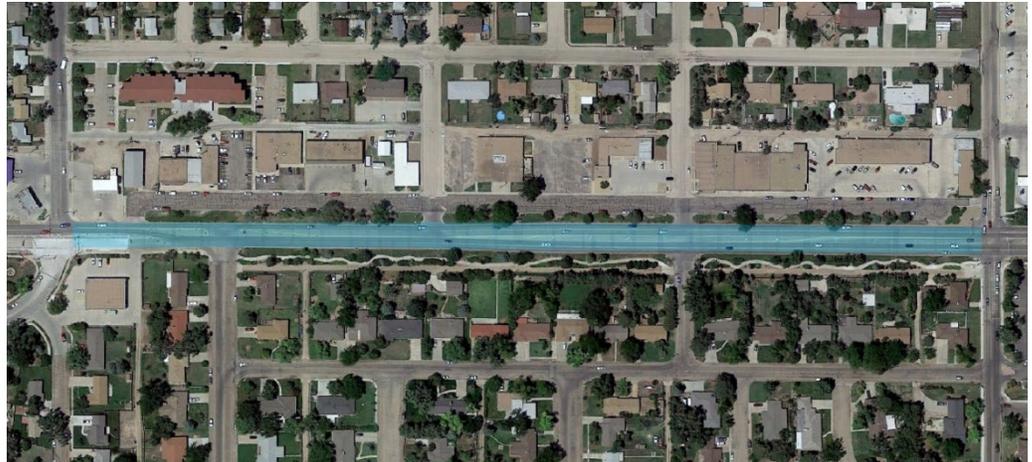
Figure 74 - Aerial View of Kansas Ave between 3rd Street and Center Street

The Kansas Avenue segment from 3rd Street to Center Street is a four lane road with a two-way left turn lane (TWLTL) throughout (Figure 75) and is 0.37 miles long. The north side of this segment of Kansas Avenue is zoned for Neighborhood

Shopping District and is comprised of mostly of locally-owned businesses. The south side of this segment is zoned for Single Family Residential and is comprised of single-family homes.

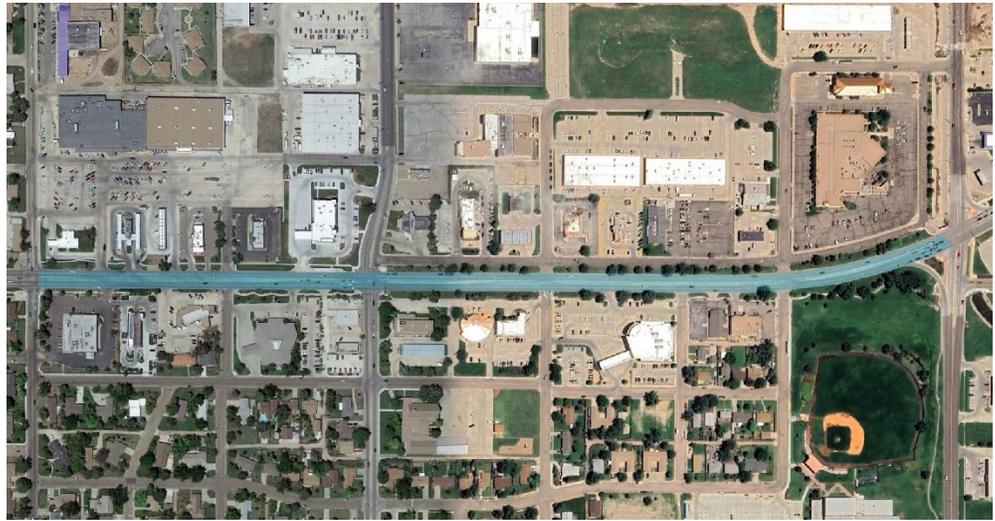
Figure 77 - Aerial View of Kansas Ave between Center Street and Campus Drive

The Kansas Avenue segment from Center Street to Campus Drive is a four lane road with a two-way left turn lane (TWLTL) throughout (Figure 78) and is 0.63 miles long. This segment of Kansas Avenue is comprised of commercial land uses including Walgreens, Dillon's, fast food establishments, banks, a Tommy's Car Wash, an urgent care, and other similar uses. Garden City Community College is located just to the south of this segment along Campus Drive.

There are 5-foot detached sidewalks on both sides of the street between Center and Fleming, with power poles running along the outside edge of the sidewalks. Between Fleming St and Campus Dr, there are 5-foot detached sidewalks on the south side of the street. The sidewalks on the north side of Kansas Avenue between Fleming and Campus are located along the north side of the frontage road (Kansas Plaza), which is separated from the main roadway by a median. There is one marked crosswalk across a stop sign-controlled site street, on the south leg of the JC St and Kansas Avenue intersection. There are no bike lanes or paths along Kansas Avenue. The Talley Trail crosses Kansas Avenue at the intersection of Kansas Avenue and Campus Drive. The daily traffic volume for this section of Kansas Avenue is approximately 19,900 VPD.

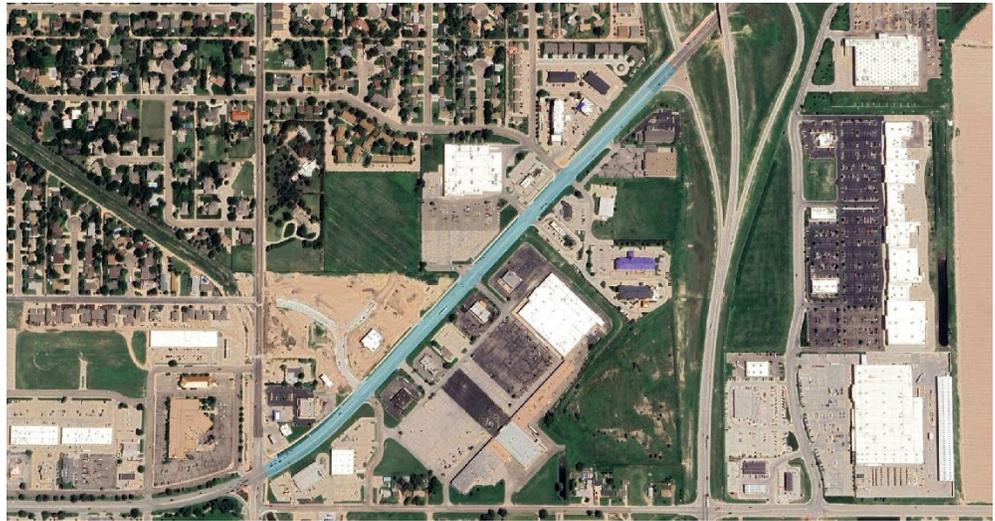
Figure 81 - Aerial View of Kansas Ave between Campus Drive and U.S. 83

The Kansas Avenue segment from Campus Drive to U.S. 83 is a four lane road with a two-way left turn lane (TWLTL) throughout (Figure 82) and is 0.71 miles long. This segment of Kansas Avenue is composed of commercial land uses and a Planned Unit Development.

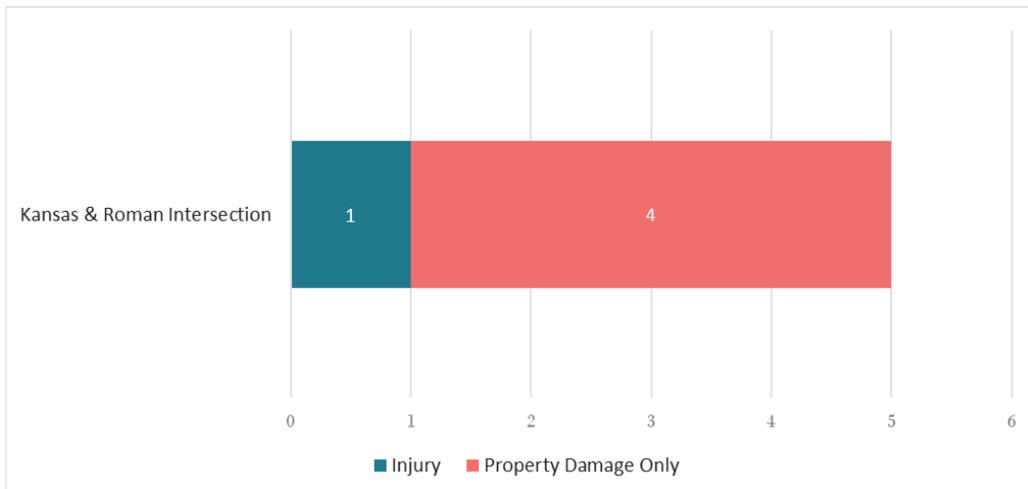
Figure 87 - Crashes at unsignalized intersections along Segment 6 from U.S. 83 to Jennie Barker Road

Figure 88 summarizes the crashes at unsignalized intersections on Kansas Avenue from U.S. 83 to Jennie Barker Road of which there was only one unsignalized intersection at Roman Road (5). The most common crash types at Roman Road were related to angle – side impact where vehicles were merging, making a right turn, and driving straight/following road.

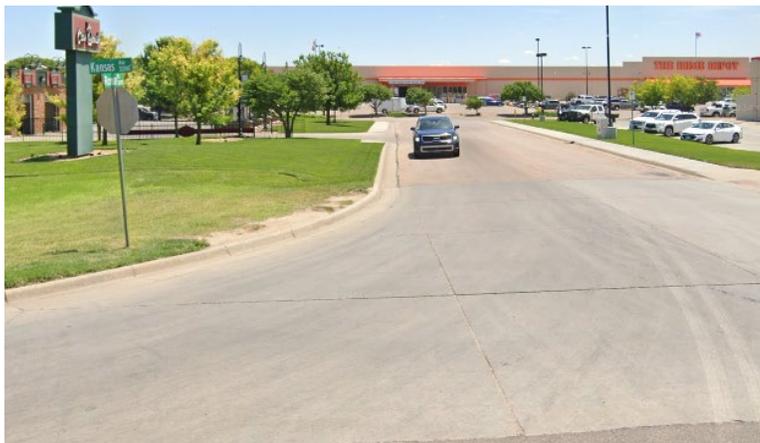
Figure 88 - Photo of Kansas Ave at Roman Rd

- Several stop lines and crosswalks were faded.
- There were faded stop lines at some side street intersections (Figure 89).
- There are no sidewalks approaching Jennie Barker Road.
