Garden City Road Safety Audit

Kansas Avenue: Taylor Avenue/U.S. 83B to Jennie Barker Road

Prepared by: **WILSON**
&COMPANY

March 2025

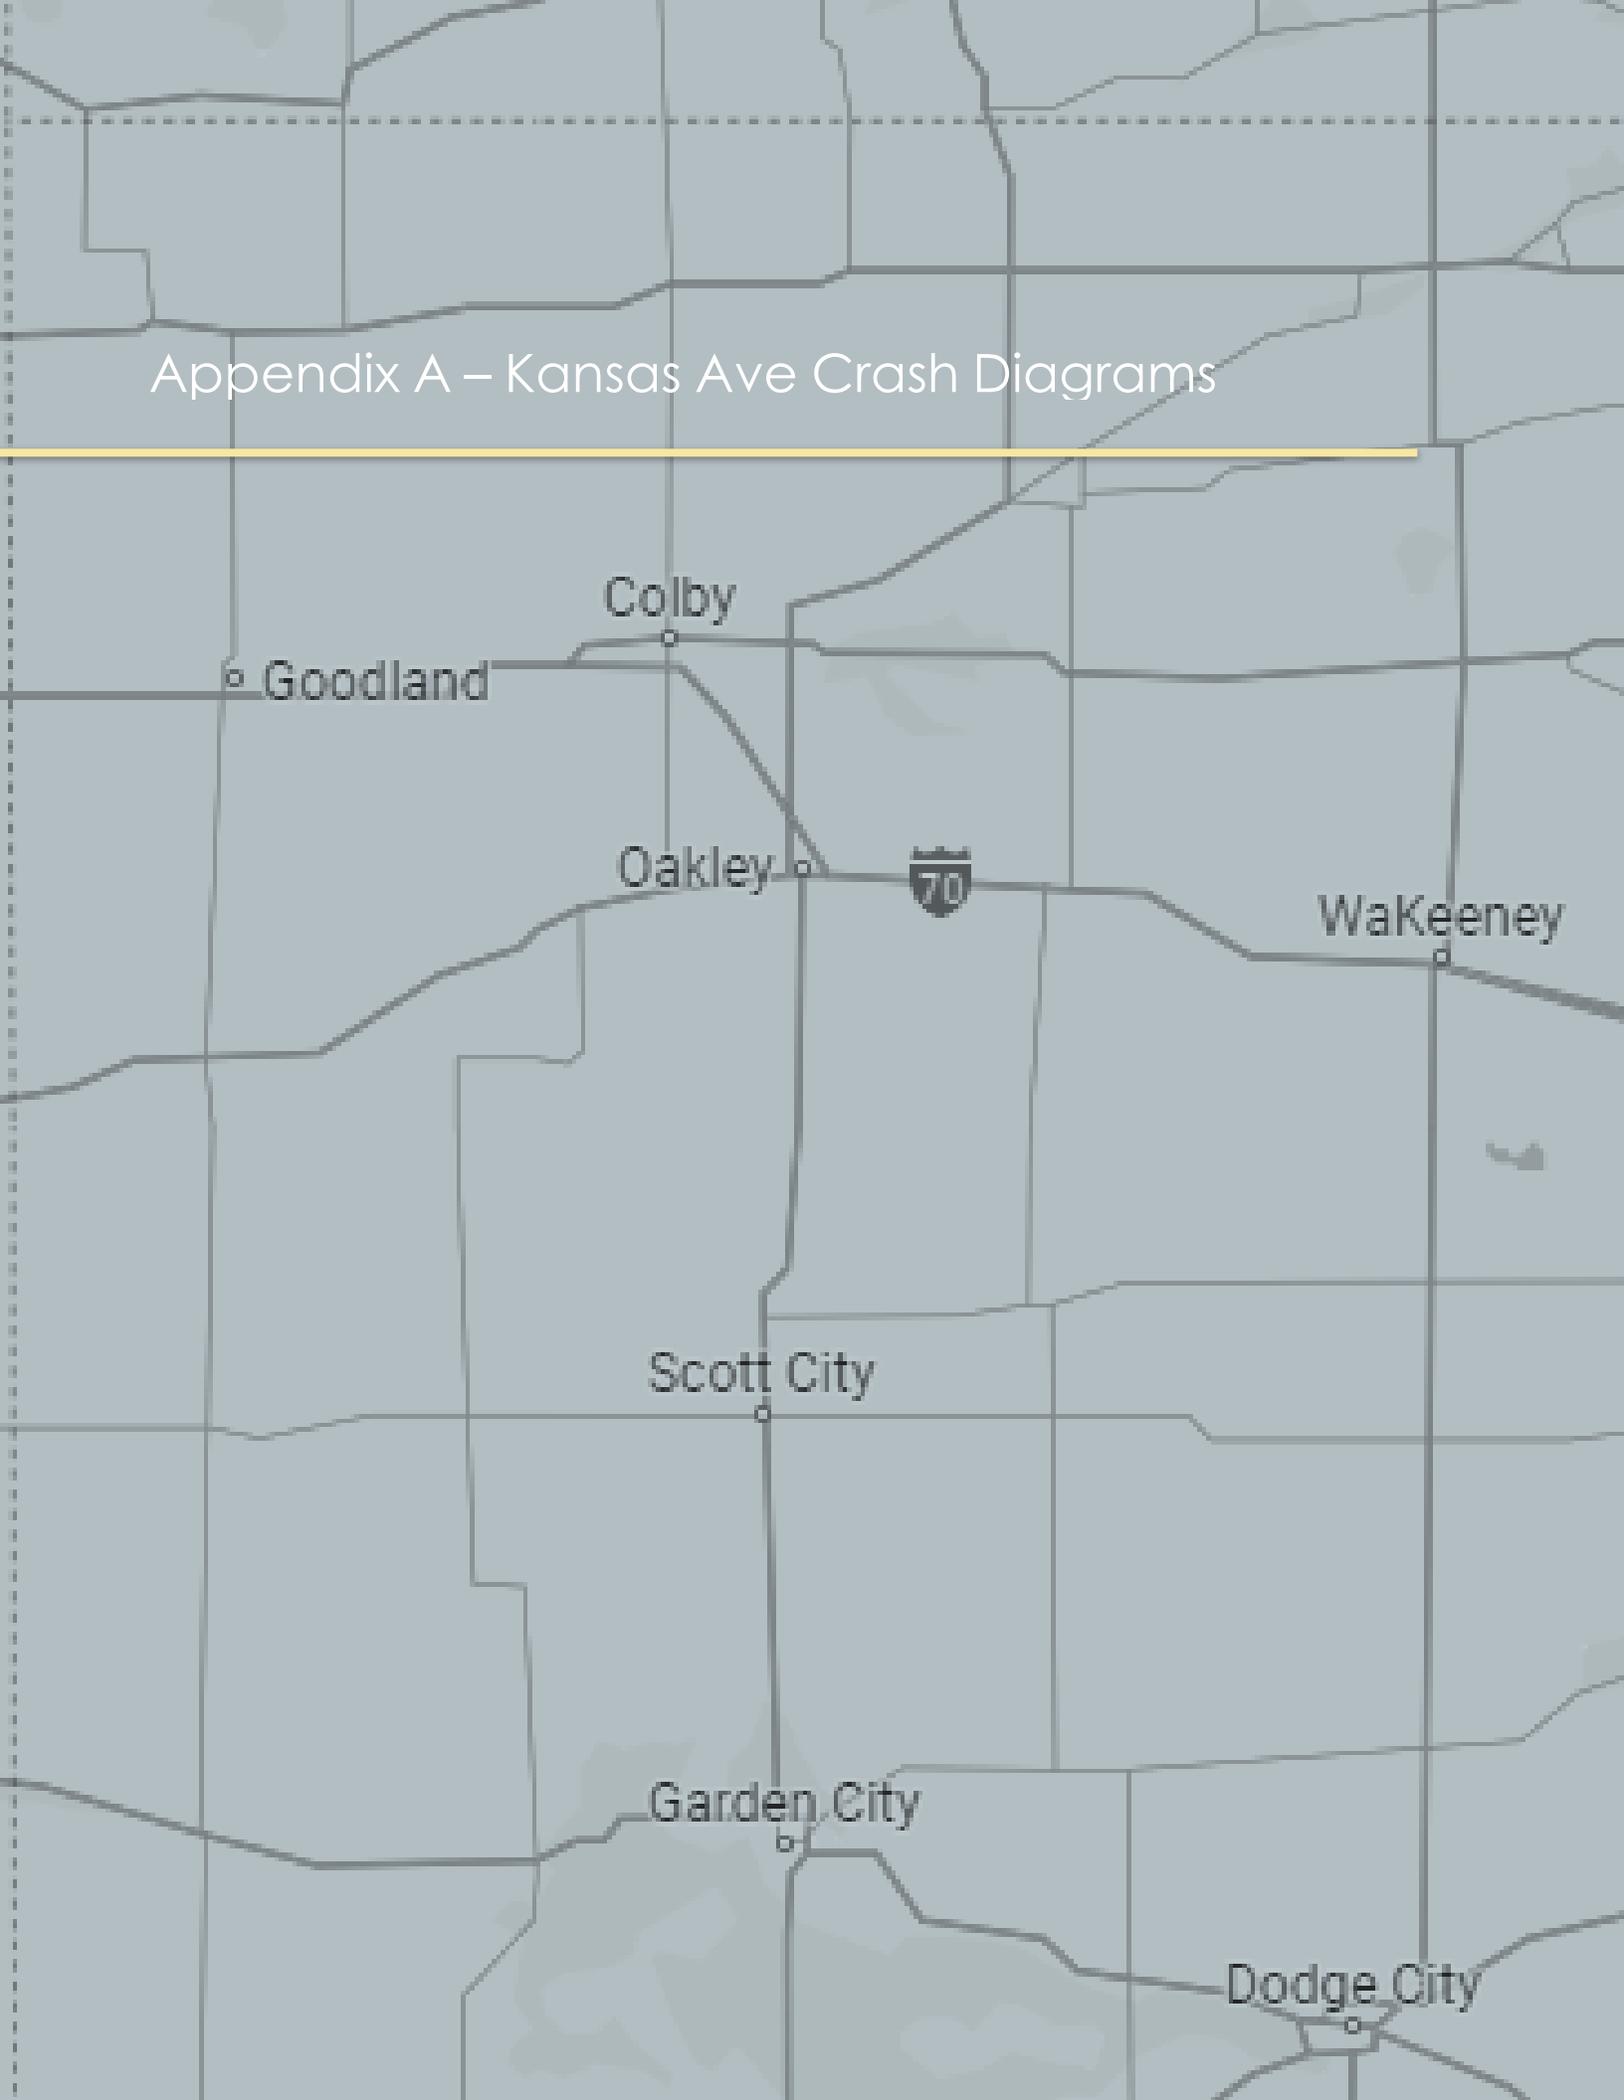
W Buffalo Jones Ave, W Kansas Ave & N Taylor Ave - Collision Diagram

Crash Data Collected : 2018 - 2022

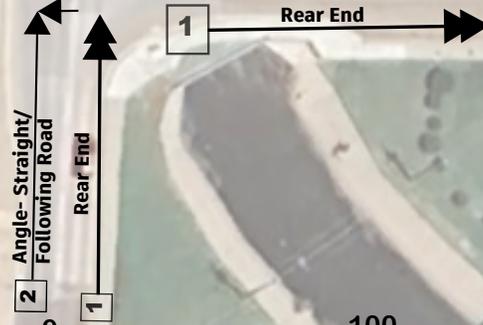
Summary - Campus & Schulman	Crash Severity	Total
	PDO	
Fixed Object	1	1
Rear End	2	2
Angle - Straight/ Following Road	2	2
Total	5	5
