Garden City Road Safety Audit

Intersections:

Prepared by: **WILSON**
&COMPANY

March 2025

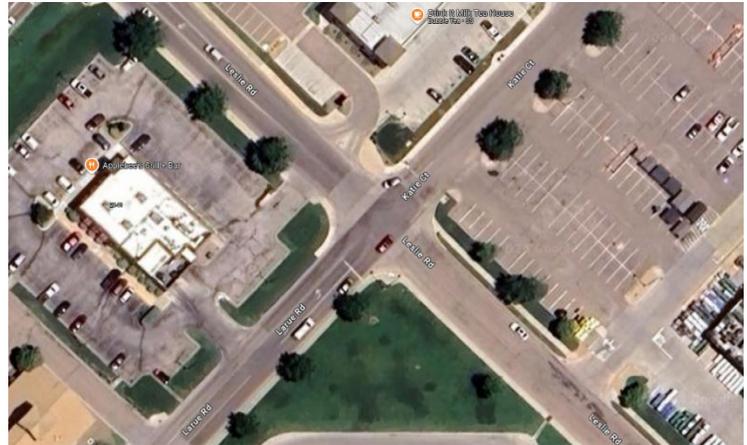
Figure 1: Aerial Image of Leslie Road & Lareu Road Intersection
 Source: Google Maps, Google. Accessed October 2024.

The Leslie Road and Lareu Road intersection, shown in Figure 1, has 3-way stop control, with stop signs on each leg except for the northwest leg. The northeast and southeast legs of the intersection are two-lane unstriped roadways. The northwest leg is a two-lane roadway that expands to the northwest to include a dedicated left-turn lane onto Kansas Avenue. The southwest leg is striped for a dedicated left-turn lane onto Leslie Road. Right-turns must be made from the shared through lane in all directions.

Attached sidewalks are present on all legs of the intersection, except for the northern side of the southwest leg of Leslie Road and the southern side of the northeast leg. Daily traffic at the intersection is estimated to be approximately 6,200 VPD on the northwest leg, 2,200 VPD on the southeast leg, 2,700 VPD on the northeast leg, and 4,800 VPD on the southwest leg.

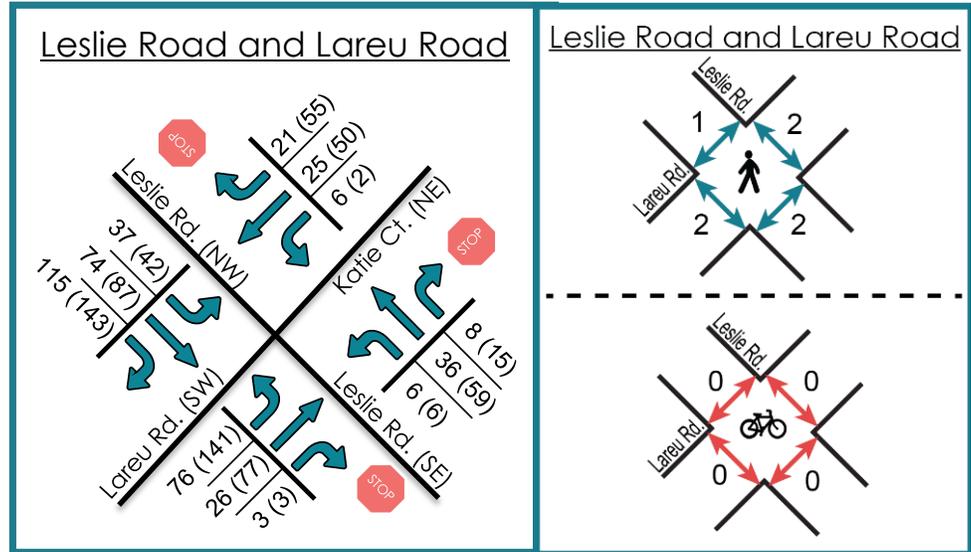
Figure 2: Leslie Road & Lareu Road 2024 Peak Hour Turning Movement Counts & Pedestrian and Bicycle Counts

This intersection is within a shopping center. Traffic reaches its peak at 12:00 p.m. and remains fairly constant through 7:00 p.m. Figure 2 shows the AM (10:00-11:00) and PM (2:00-3:00) peak-hour traffic volumes. There were no recorded bicyclists at the intersection over the 13-hour count period on the day of the data collection, however there was a small amount of pedestrians crossing at each leg, shown in Figure 2.

- Appears to be driver confusion on right-of-way amongst the 3 stop-controlled approaches.
- Drivers observed disregarding RIRO restrictions at driveway just northwest of the intersection.

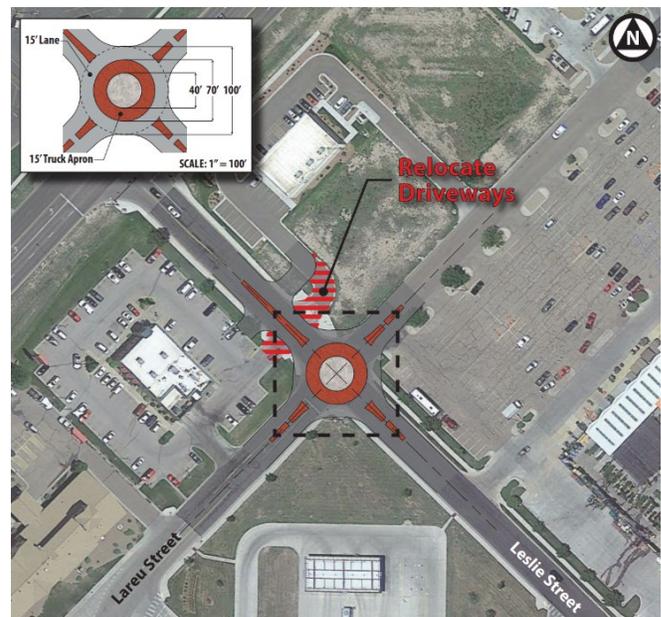
Figure 3: 2016 Traffic Study Conceptual Leslie Road & Lareu Road Recommendation

The following improvements are recommended for the intersection. A traffic study was completed in 2016, *Traffic Study of Corridors and Intersections*, that recommended the intersection of Leslie Road and Lareu Road be reconstructed as a roundabout as the surrounding area develops to allow for increased efficiency. A conceptual image from the plan is included in Figure 3. This recommendation was also included in the *Garden City 2021 Capital*

Improvement Plan alongside a reconstruction of Leslie Road from Kansas Avenue to Lareu Road (Projects PWL-21-002 and PWL-21-003).

1. Reconstruct the intersection as a single-lane roundabout.
 - a. Based on the existing weekday PM peak-hour traffic volumes, the intersection is expected to operate at LOS A as a roundabout, with queue lengths of no more than one vehicle. Given the driver confusion with the current 3-way stop condition, the overall intersection level of service would likely be improved with a roundabout as compared to the current conditions.

- b. However, it is recommended the intersection be analyzed further to take into account the potential for increased traffic volumes as the surrounding area develops to ensure that traffic would not back up from the signal at Kansas Avenue through the roundabout.

2. Alternatively, or as an interim measure, consideration could be given to operating the intersection as an all-way stop, which could also be expected to operate at LOS A based on existing weekday PM peak-hour traffic volumes. However, as the intersection had previously been operated as an all-way stop and was converted to the current three-way stop configuration, the reasons for that previous change in traffic control should be investigated before making any further changes.

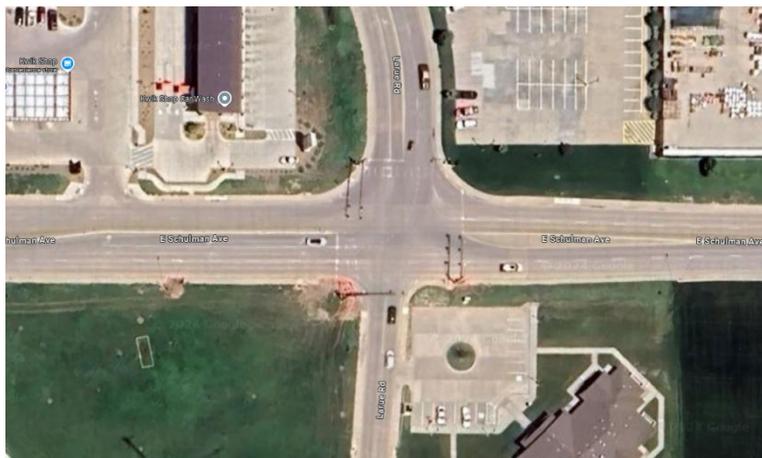
Figure 5: Aerial Image of Schulman Avenue & Lareu Road Intersection

- Although there is adequate pavement width on the east leg for a westbound turn-lane, no such lane exists.
- Push buttons in the southwest and southeast corners are far from the curb ramps.

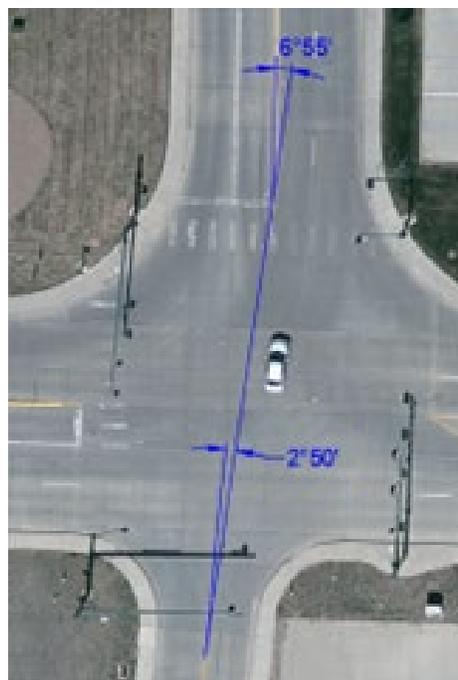
Figure 4: Schulman Avenue & Lareu Road Intersection Lane Geometry

Schulman Avenue and Lareu Road is a signalized intersection (Figure 4). The east and west legs of Schulman Avenue each have two through lanes in each direction and the west leg has a dedicated left-turn lane as well as a combined through – left-turn lane onto the north leg of Lareu Road. The north leg of Lareu Road has one through-right lane and one dedicated left-turn lane along with two through lanes for the northbound movements. The south leg of Lareu Road has one lane in each direction with no dedicated turning lanes. Right-turns must be made from the shared through lane in all directions. There is protected/permissive left-turn phasing for the eastbound approach.

The northbound through lane does not align with the receiving lane on the north side of the intersection. The offset is geometrically deficient, with a 2°50' deflection on the south side and a nearly 7-degree deflection on the north side. The acceptable deflection for 30 mph design speed is 3°45', thus the existing deflection is double the design standard. This deflection is shown on the right. Attached sidewalks are present on all legs of the Schulman Avenue and Lareu Road intersection. There are no bike lanes at this intersection. Daily traffic at the intersection is approximately 7,700 VPD on the west leg, 4,300 VPD on the east leg, 6,800 VPD on the north leg, and 1,900 VPD on the south leg.

1. Reconfigure the intersection such that there are two exclusive eastbound left-turn lanes through re-striping to convert the shared through/left-turn lane to an exclusive left-turn lane, leaving a single eastbound through lane. The existing configuration with an exclusive left-turn lane and a shared through/left-turn lane, in combination with protected/permissive left-turn signal phasing, is awkward and violates the MUTCD requirement that a separate left-turn signal face operated in protected/permissive mode shall not display a circular green indication (MUTCD Section 4F.08(02)). In conjunction with such a lane reconfiguration, the existing five-section left-turn signal heads should be replaced with flashing yellow arrow (FYA) heads. The realignment should also correct the geometric deficiency caused by the northbound deflection.

2. Add a westbound left-turn lane through re-striping of the east leg, in order to provide left-turning drivers with their own lane and protected signal phase.

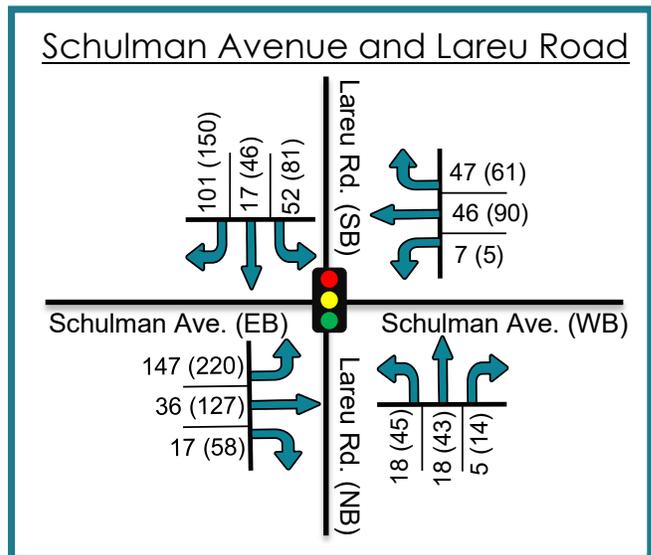
Figure 6: Schulman Avenue & Lareu Road 2024 Peak Hour Turning Movement Counts

With much of the traffic traveling through this intersection being generated by retail land uses, the traffic volume gradually increases throughout the day, reaching its peak around 5:00 p.m. Figure 6 shows the AM (10:00-11:00) and PM (4:45-5:45) peak-hour traffic volumes. There was one bicyclist that crossed the south leg of the intersection during the 13 hour timeframe. Pedestrians were recorded along each leg except for the southbound approach of Lareu Road (Figure 7).

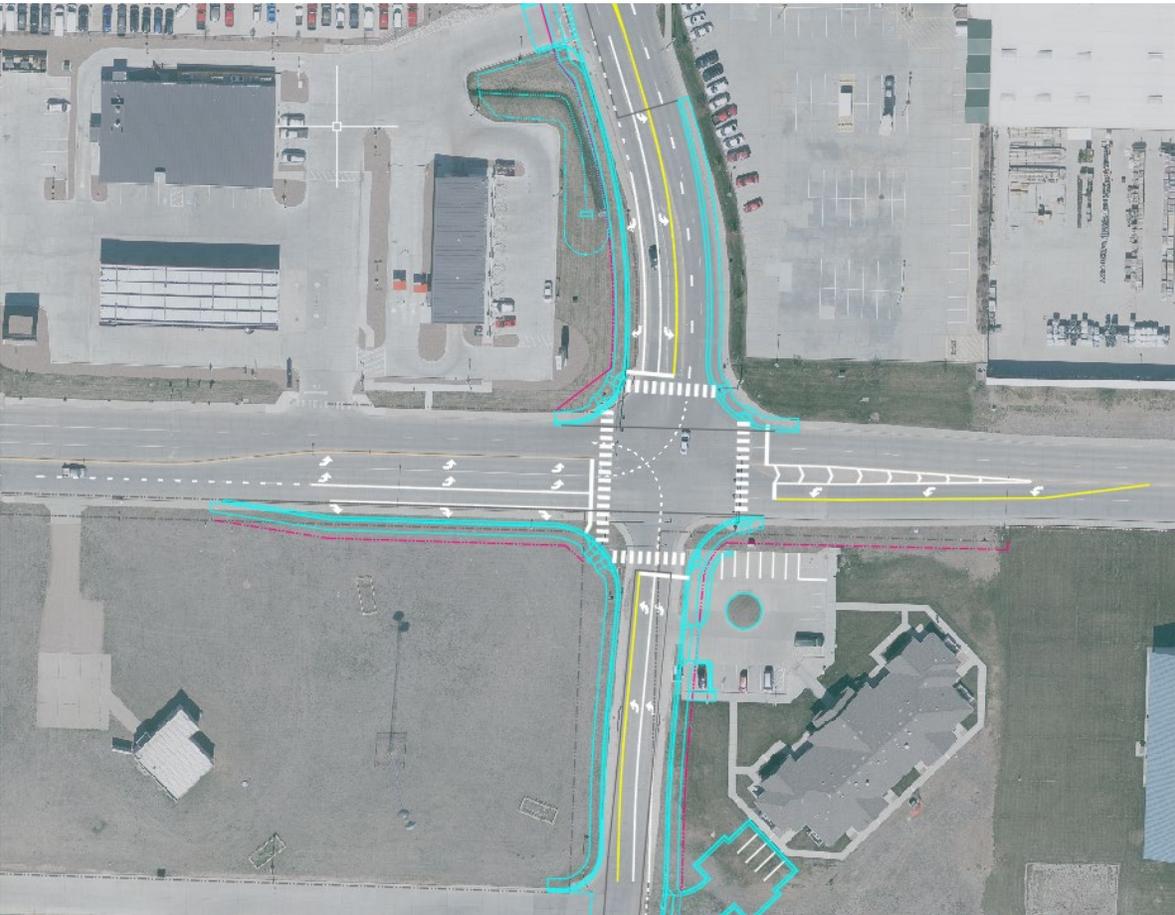
Figure 8: Conceptual Ultimate Intersection Build Out

3. Add one or two northbound left-lanes and an eastbound right-turn lane in order to adequately serve the traffic demand expected to be created by developments south of the intersection, both under construction and in the planning process.

4. Add a southbound right-turn lane in order to better serve the traffic demand from the north, both existing and future, as the shopping center is not yet fully developed.

5. Rebuild the traffic signal to support the additional lanes recommended above, to meet requirements related to pedestrian elements, to add FYA signal heads, and to add signal head backplates with retroreflective borders.

6. Without the additional lanes and other improvements noted above, the intersection is expected to operate poorly as the surrounding area is built out, leading to congestion that would likely result in vehicle queues spilling out of turn lanes and blocking upstream intersections, which could have significant negative impacts on safety.

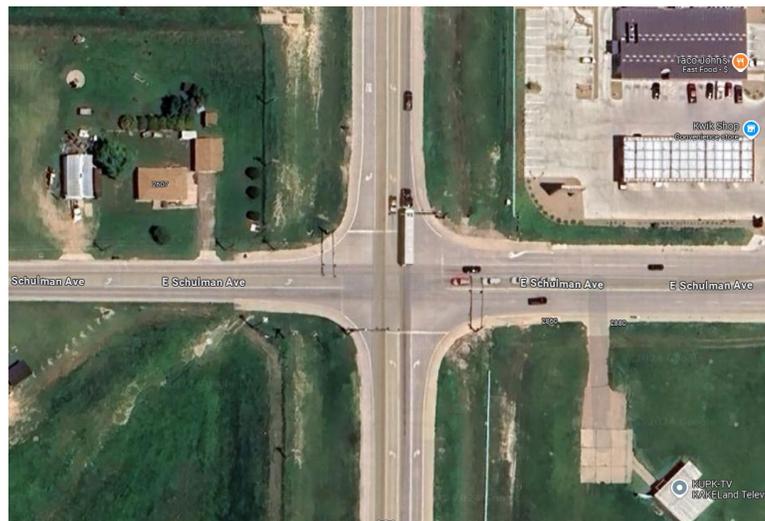
Figure 9: Aerial Image of U.S. 83 & Schulman Avenue Intersection

U.S. 83 and Schulman Avenue is a signalized intersection (Figure 9). The NB/SB legs (US 83) have three-lane approaches, with exclusive left-turn, through, and right-turn lanes, and a single departure lane. The west leg has a two-lane approach, with an exclusive left-turn lane and a shared through/right-turn lane, and a single departure lane. The east leg has a three-lane approach, with an exclusive left-turn, through, and right-turn lane, and two departure lanes. There is protected-only left-turn phasing for every approach and right-turn overlap phasing on the NB/SB approaches. There is no pedestrian signal phasing at the intersection. There is a “Be Prepared To Stop” warning sign with flashing beacons on the SB approach located 850 feet north of the intersection, but no such beacon exists for the NB approach.

There are no sidewalks along the intersection, except for a section of attached sidewalk along the northern side of westbound Schulman Avenue in front of the KwikShop. There are no bike lanes on U.S. 83 or Schulman Avenue. Daily traffic at the intersection is approximately 3,800 VPD on the west leg, 7,800 VPD on the east leg, and 10,500 VPD on the north and south legs. There is significant truck traffic on U.S. 83, with approximately 25% of the NB/SB through traffic being articulated trucks and another 5% being single-unit trucks or buses.

- No pedestrian infrastructure directly along the intersection. There are sidewalks along Schulman Avenue, along the north and south of the east leg approximately 100 feet from the intersection. Along the west leg of Schulman Avenue, there are sidewalks in front of Mision Cristiana Elim, apprioxmiately 500 feet from the intersection. The west leg also allows for a connection to the Talley Trail, bringing in many pedestrians and cyclists. Several major businesses such as Mendards, Parrot Cove, and the Schulman Crossing Shopping Center have been identified by the community as important locations to be able to walk to for the surrounding residential areas.

- The left-turn movements on every approach have protected-only signal phasing, but the left-turn signal heads have circular red signal indications, which is a violation of MUTCD requirements. Per MUTCD Section 4F.06(02A), if a separate left-turn signal face is provided for a protected only mode left turn, it shall be capable of displaying a left-turn red arrow.

2. Update the left-turn signal heads to include red arrows, in order to meet MUTCD requirements.
3. Install a Signal Ahead (W3-3) warning sign on the SB approach, upstream of the Be Prepared To Stop (W3-4) warning sign, as required by MUTCD Section 2C.35(09).

4. Install a When Flashing (W16-13P) plaque under the existing W3-4 sign on the SB approach, as recommended by MUTCD Section 2C.35(10).
5. Install a W3-3 sign and a W3-4/W16-13P sign with flashing beacons on the NB approach, given the high speed limit, heavy truck volume, and public complaints of red light running.

6. Add retroreflective yellow borders to the signal head backplates for improved visibility.
7. Consider adding supplemental pole-mounted left-turn signal heads for every approach to provide added visibility for approaching traffic that is traveling behind large vehicles, as recommended by MUTCD Section 4D.05(07.E).

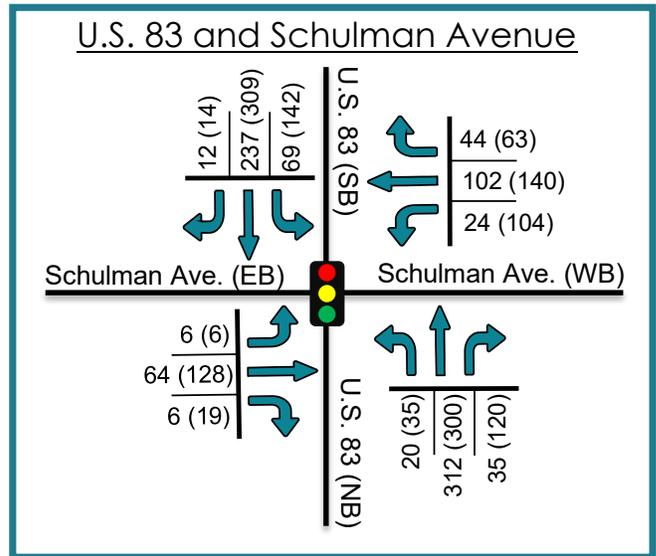
Figure 10: U.S. 83 & Schulman Avenue 2024 Peak Hour Turning Movement Counts

Overall, traffic volumes are higher in the PM peak hours than the AM peak hours. Other than the northbound and southbound through movements, the predominant traffic flow at the intersection involves vehicles turning between the east, south, and north legs (Figure 10). A bicyclist crossed along the south leg of U.S. 83, as well as a pedestrian crossing along the north leg of U.S. 83 (Figure 11). The pedestrian crossed from the northeast corner to the northwest corner at 12:54 p.m., running across US 83 while its traffic had green signal indications, passing behind a vehicle stopped in the SB left-turn lane.

- Northbound queuing observed to extend nearly to Spruce Street.

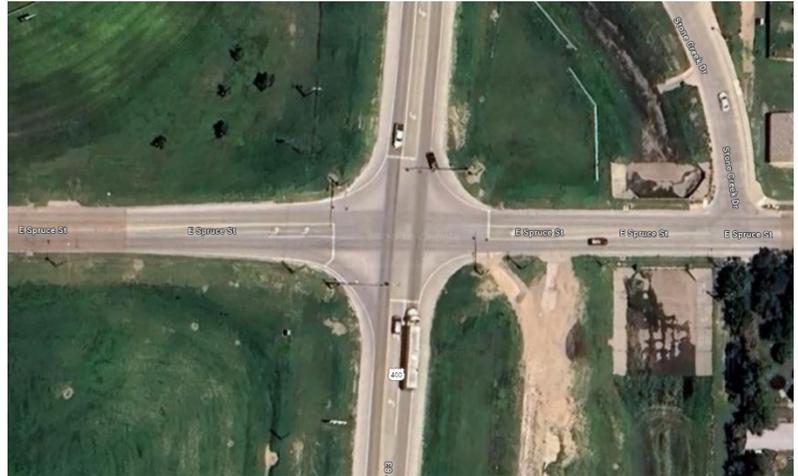
Figure 12: Aerial Image of U.S. 83 & Spruce Street Intersection

U.S. 83 and Spruce Street is a signalized intersection (Figure 12). Every approach has two lanes, with an exclusive left-turn lane and a shared through/right-turn lane, and a single departure lane. Right-turns must be made from the shared through lane in all directions. There is protected/permissive left-turn phasing for the northbound and southbound approaches and no left-turn phasing for the eastbound and westbound approaches. There is currently no pedestrian signal phasing at the intersection. There is a “Be Prepared To Stop” warning sign with flashing beacons on the NB approach located 620 feet south of the intersection, but no such beacon exists for the SB approach.

There are no sidewalks or bike lanes on U.S. 83 and Spruce Street, though a trail extension project is expected to add an at-grade crossing on the north leg of the intersection in 2025. Daily traffic at the intersection is approximately 6,800 VPD on the west leg, 5,400 VPD on the east leg, and 11,100 VPD on the north and south legs. There is significant truck traffic on US 83, with approximately 25% of the NB/SB through traffic being articulated trucks and another 5% being single-unit trucks or buses.

- No pedestrian infrastructure directly within the intersection. Attached sidewalks start along Spruce Street approximately 500 feet to the west and approximately 225 feet to the east. The neighborhoods adjacent to the intersection also have sidewalks. An elementary school and the school district's sport fields are just off Spruce Street, which could cause an increase in pedestrian traffic. The Talley Trail also ends northwest of the intersection, which brings many pedestrians and cyclists to the area.
- Auxiliary lanes are shorter than the standard length.
- Southbound queuing observed near the Schulman intersection.

1. Lengthen auxiliary lanes to standard length with additional northbound/southbound dedicated right turn lanes.
2. Review the traffic signal change and clearance intervals. A preliminary review conducted for this study suggests that additional yellow time may be warranted for the NB/SB left-turn movements. Additionally, it is recommended that consistent calculation and application of the yellow change/red clearance intervals, based on industry guidance, be made at this intersection and at the U.S. 83/Schulman Avenue intersection to satisfy driver expectancy on the corridor.

- a. Install a FYA signal head over the center of each left-turn lane.
- b. Install at least one, signal head centered over each through lane, as recommended by MUTCD Section 4D.05(07.B) and MUTCD Table 4D-1.

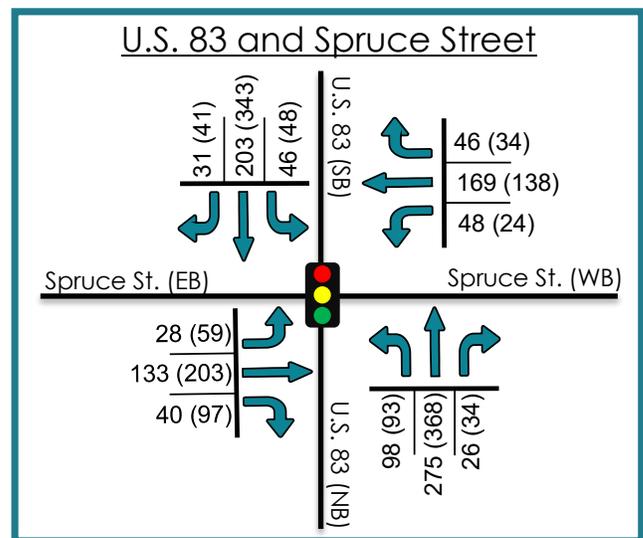
Figure 13: U.S. 83 & Spruce Street 2024 Peak Hour Turning Movement Counts

Overall, traffic volumes are about equal between the AM and PM peak hours. Other than all through movements, the predominant traffic flow at the intersection involves vehicles turning between the south and west legs (Figure 13). There were two bicyclists that crossed along the north and south legs of the intersection, however due to the lack of pedestrian infrastructure, there were no pedestrians recorded at the intersection (Figure 14). Although no pedestrians were recorded at the intersection during this time frame, pedestrians do cross at the intersection and must weigh the risks.

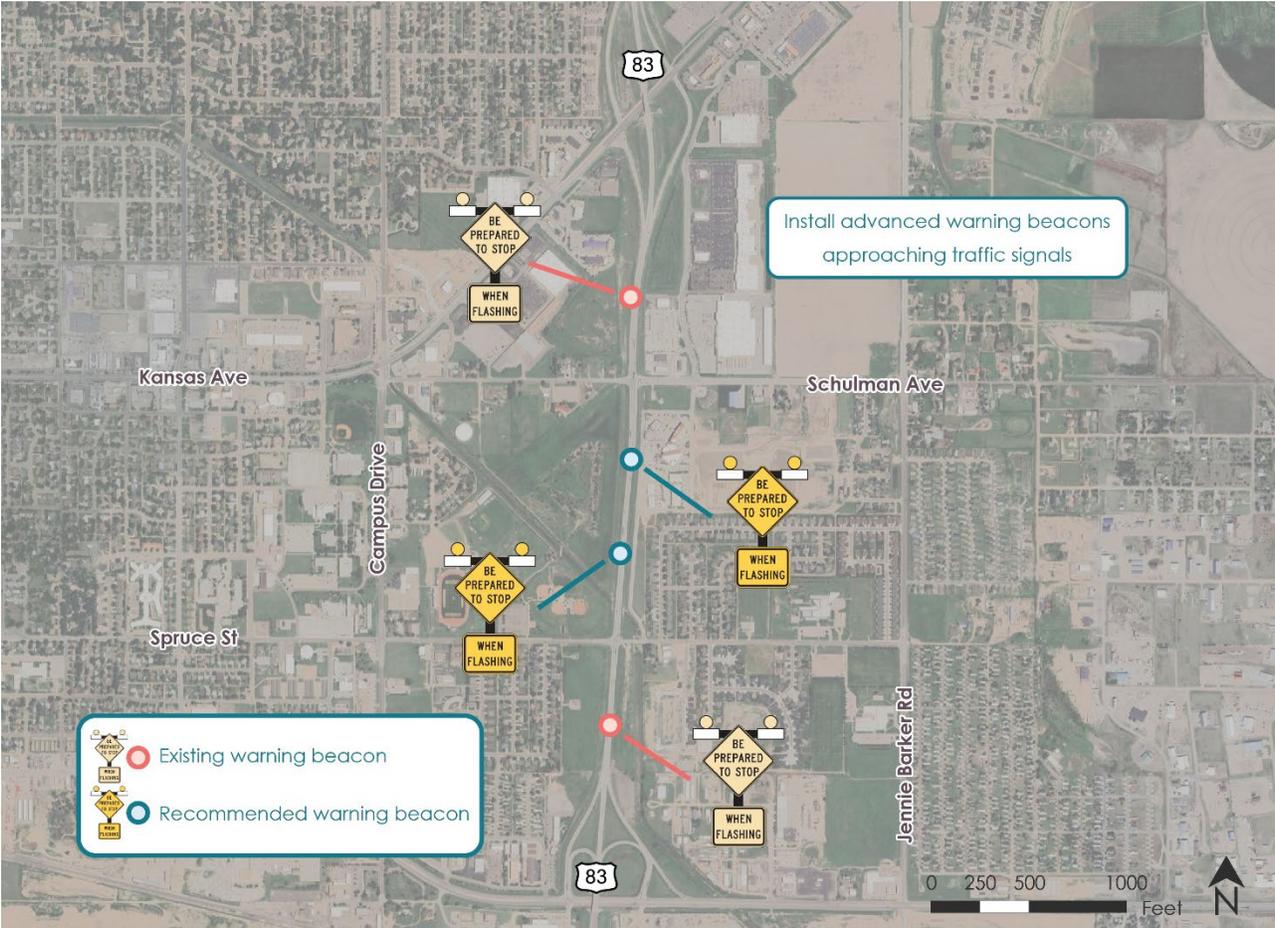
Figure 15 - U.S. 83 Systemic Short-term Recommendations

Install advanced warning beacons along U.S. 83 in Garden City approaching the traffic signals, as shown in Figure 15, and ensure the following:

- **Sync with Signal Phasing:** Connect beacons to traffic signals to alert drivers of impending change to a red indication
- **Strategic Placement:** Position beacons to allow safe deceleration
- **High Visibility:** Use LED beacons for better visibility in all conditions

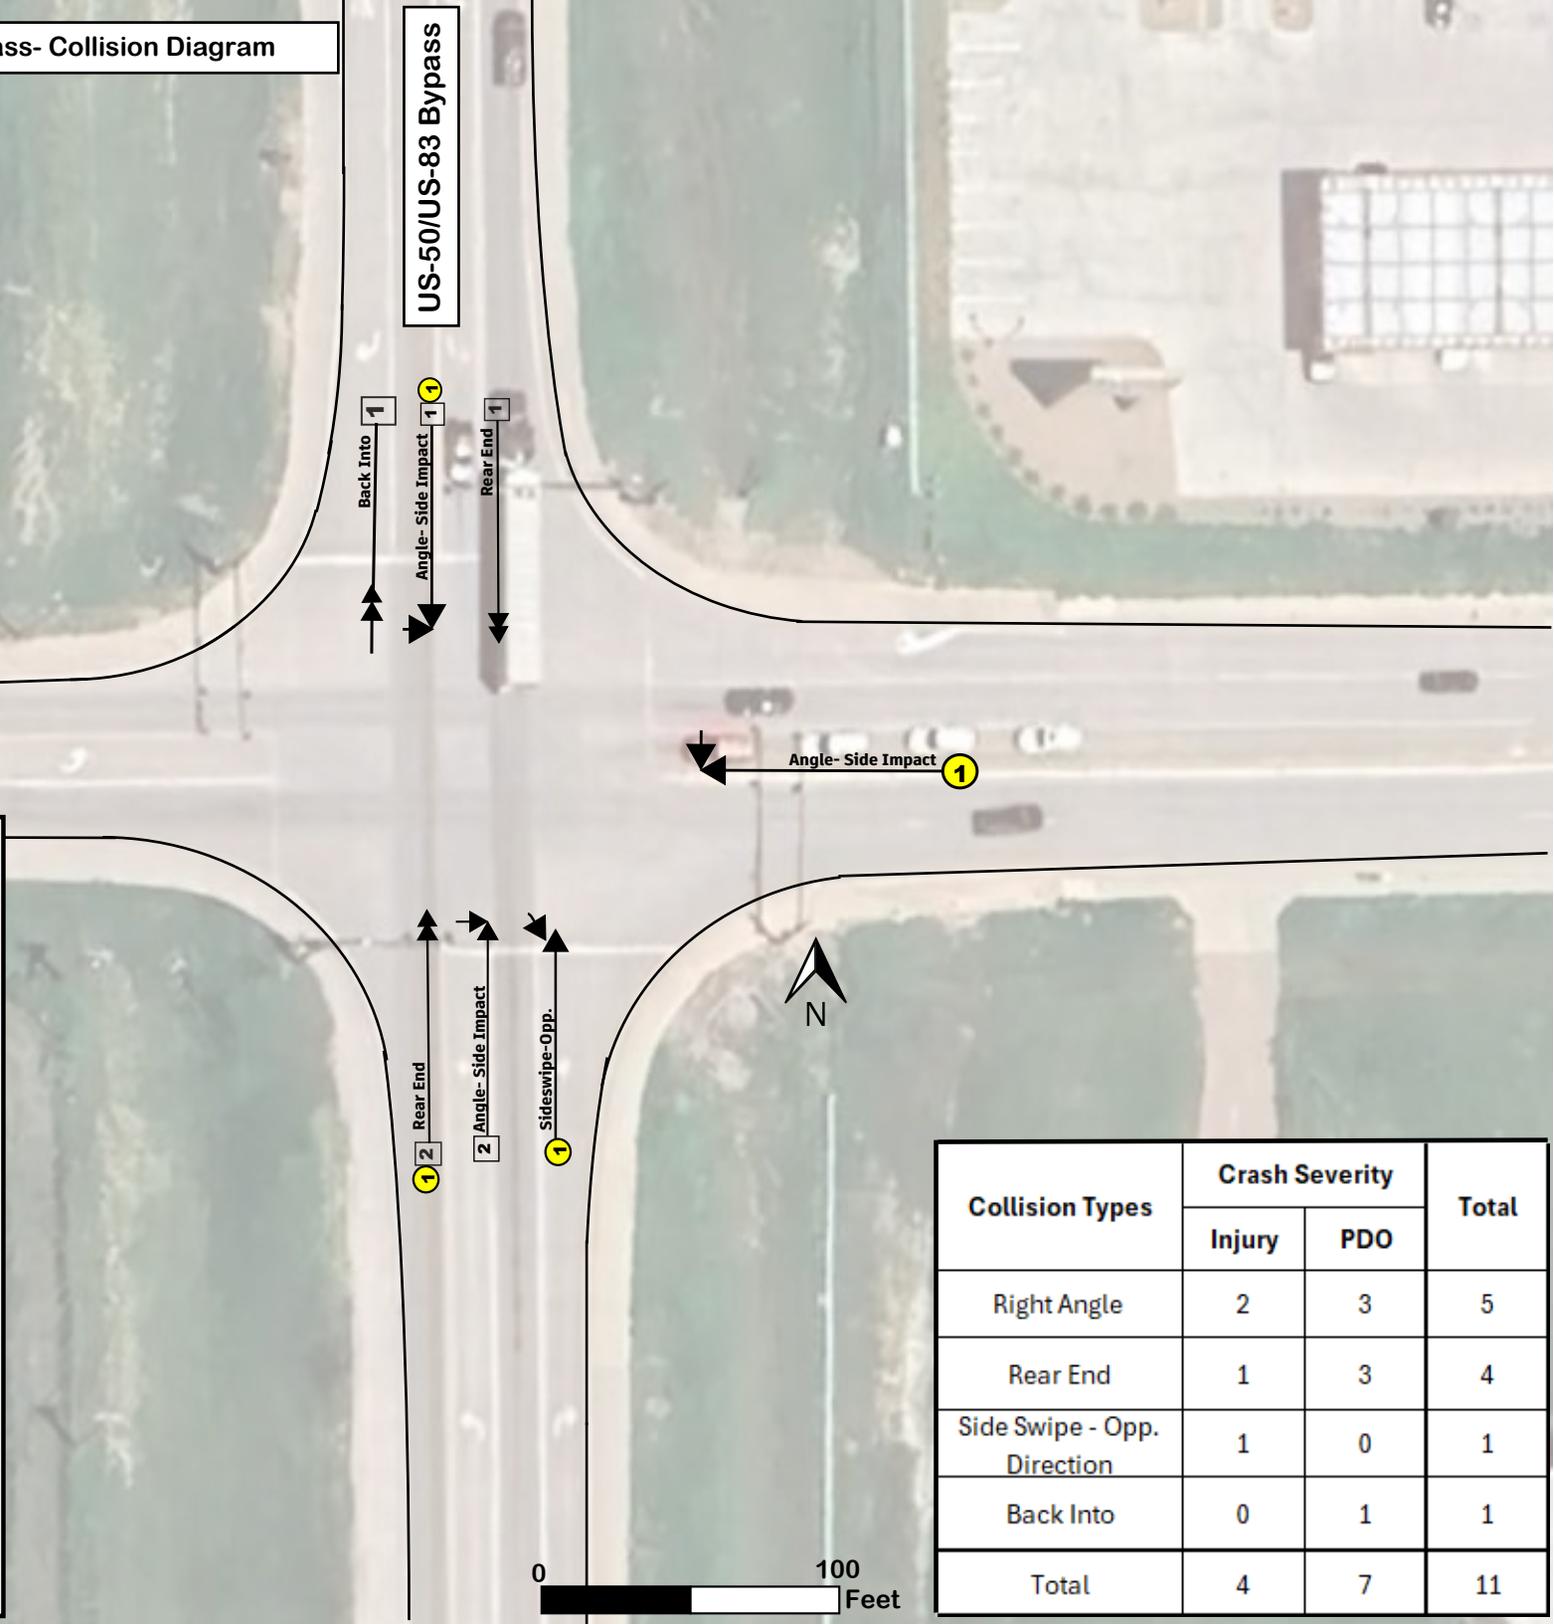
E Spruce St & US-50/US-83 Bypass- Collision Diagram

Collision Types	Crash Severity		Total
	Injury	PDO	
Right Angle	2	3	5
Rear End	1	3	4
Side Swipe - Opp. Direction	1	0	1
Back Into	0	1	1
Total	4	7	11
